Structural Engenuity

March 05, 2018

**Re: Clements Field House at Clements High School
Fort Bend ISD
Sugarland, Texas**

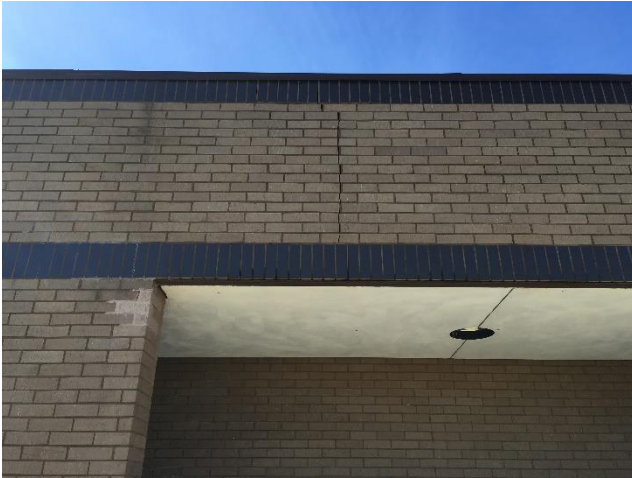
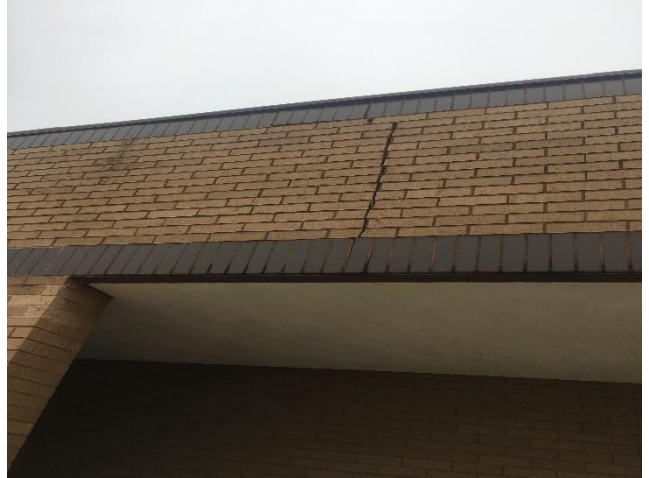
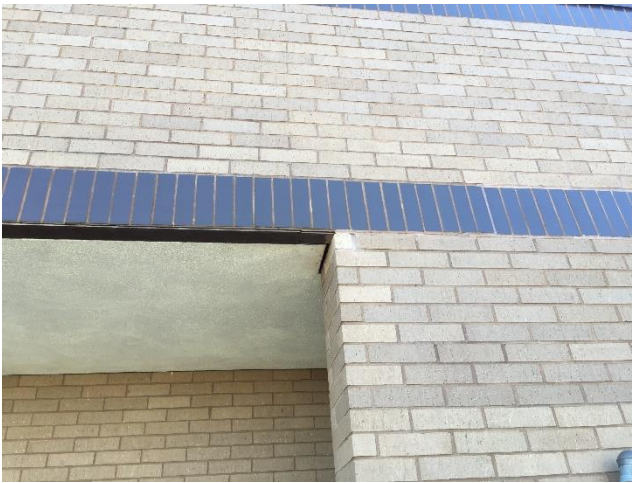
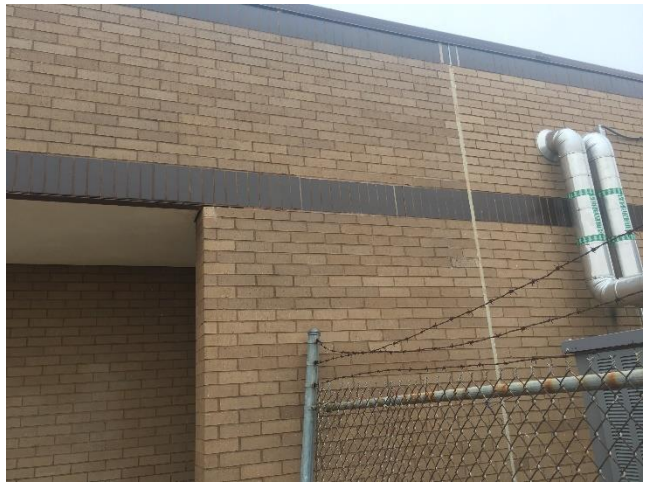
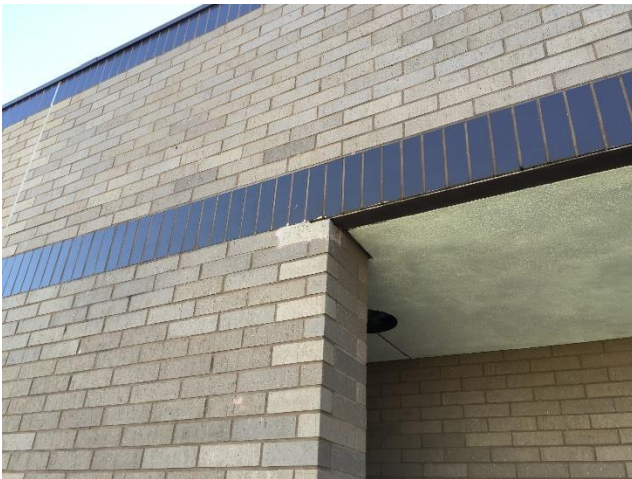
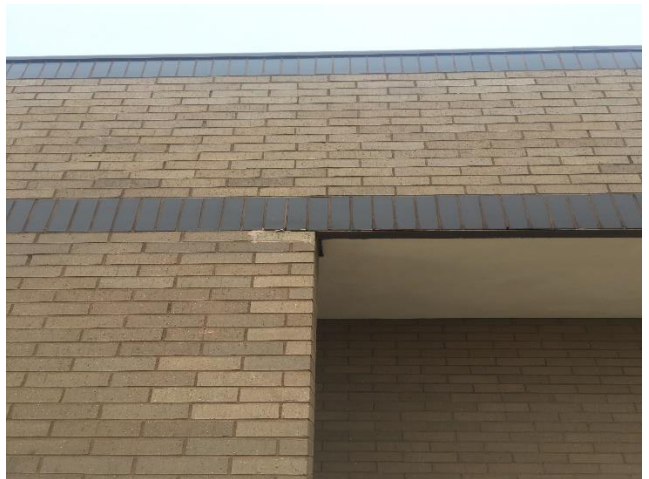
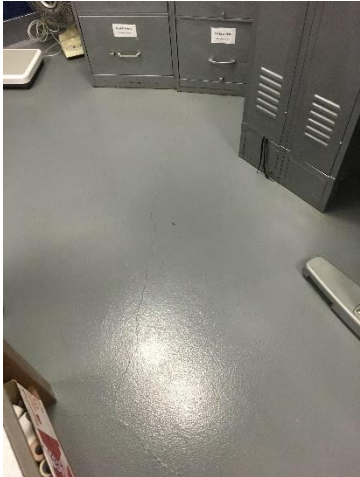
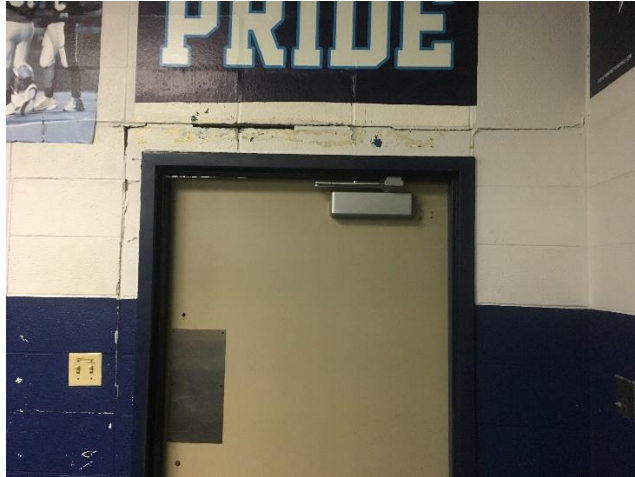
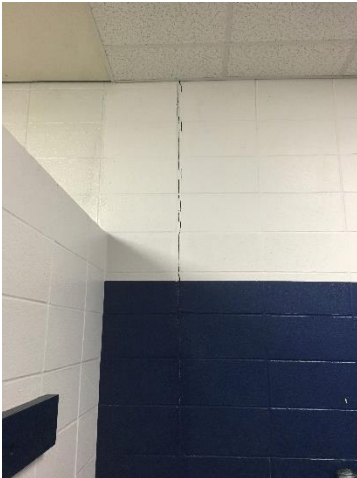
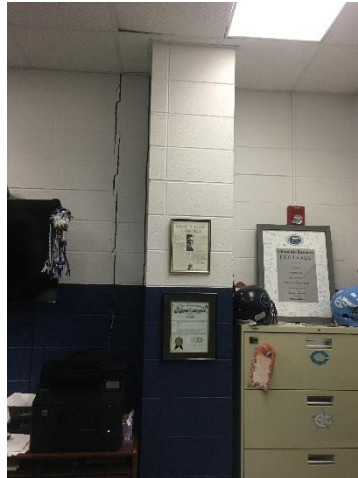
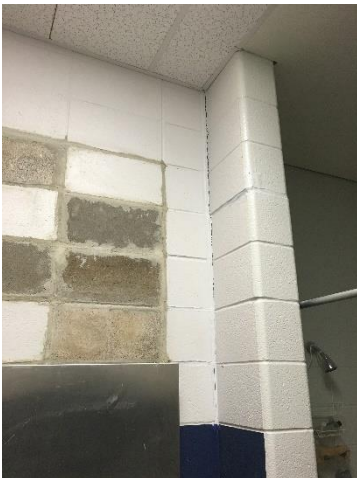
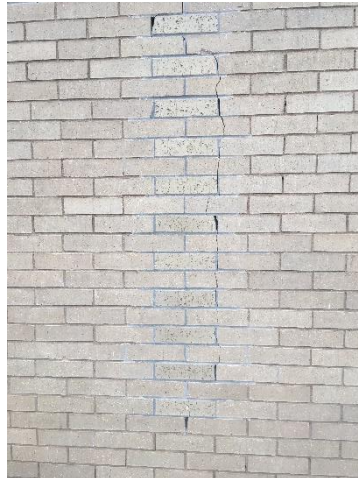
Prior to PBK's official selection for the FBISD assessment work, AG&E-SE had previously visited Clements Field House and Clements High School on behalf of another Architect. This initial visit was on February 8th, 2016 and at that time I walked the field house building and spoke with staff about the observed movement/distress. Additionally, during the walk I collected numerous photos of the various conditions, acquired general slab movement measurements, and researched the previous repair work that had been previously performed by a foundation repair contractor. A few photos of the conditions in 2016 have been provided and paired side by side with a current photo of the same condition taken during the more recent walk on January 9th, 2018.

Generally speaking, the movement at the field house has been observed to be between 1” to 4”. A typical structure is usually designed for up to 1” of potential movement; therefore, the values observed are in excess of what a typical building can tolerate. Below is a bulleted list of items we observed structurally on the field house building.
