## STRUCTURAL CONDITION ASSESSMENT REPORT

*Fort Bend Independent School District – Clements High School  
4200 Elkins Road  
Sugar Land, Texas 77479*

**Prepared by:**  
**Dally + Associates, Inc.**  
*9800 Richmond Avenue, St. 460,  
Houston, Texas 77042  
Report No.: 22-219-1  
September 12, 2022*

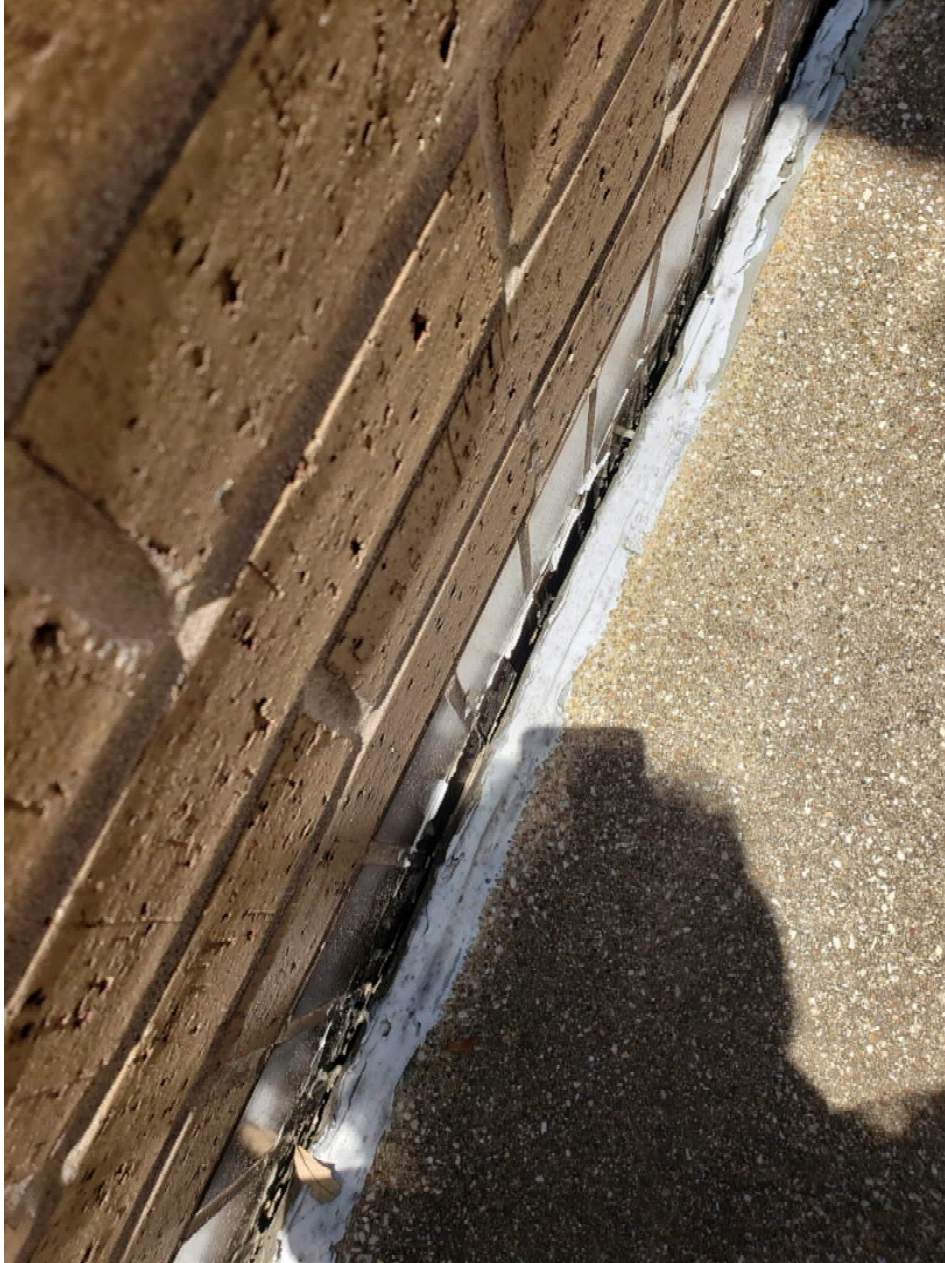
Photo 1

1. Significant cracks and movements visible around the exterior perimeter of the building.
  - Horizontal movement between the exterior cladding and adjacent paving. (See Photos 1-2.)

**Description:** Horizontal Joint between Exterior Cladding and Adjacent Paving

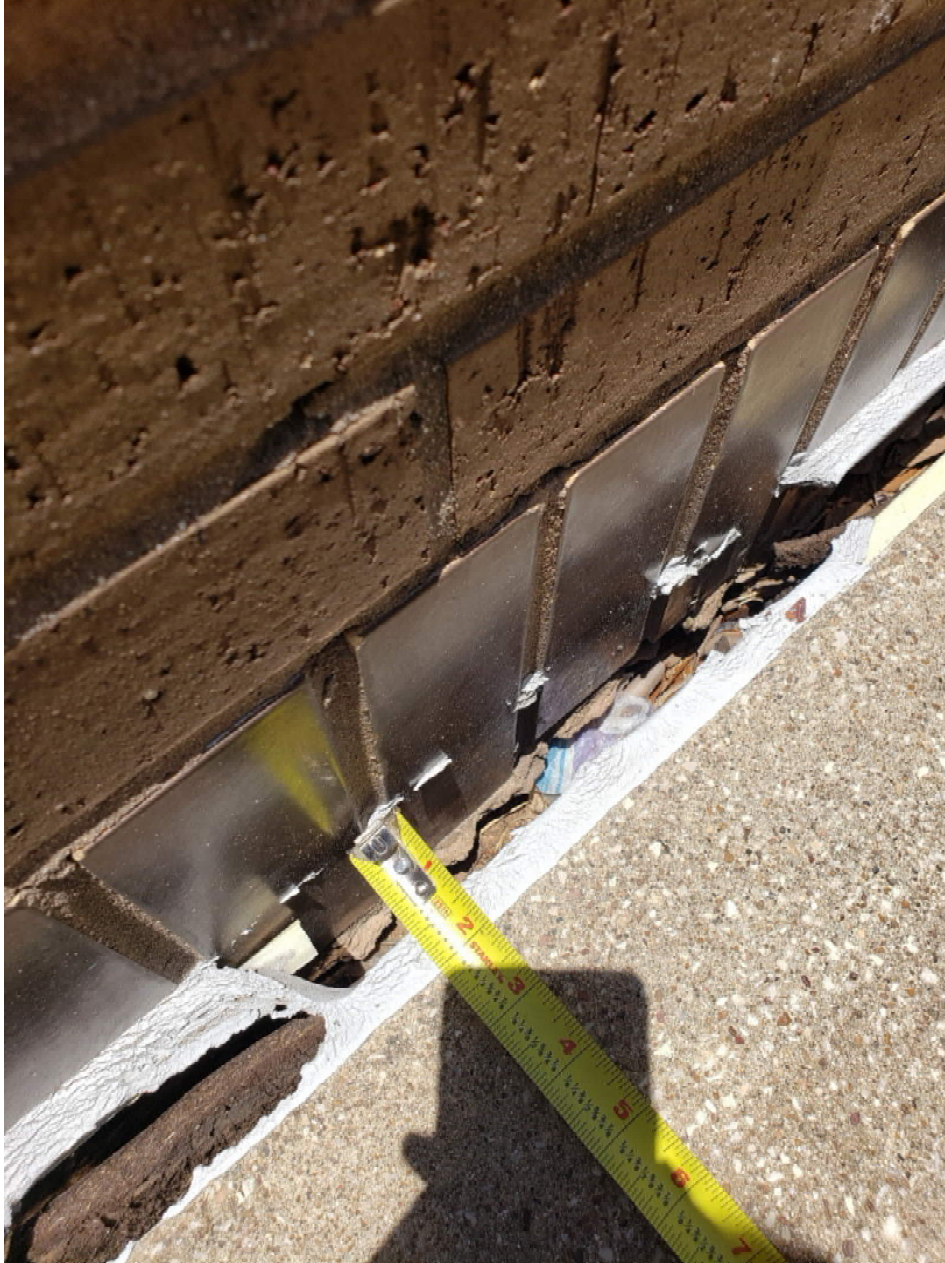
Photo 2

**Description:** 2-Inch Horizontal Movement between Exterior Cladding and Adjacent Paving

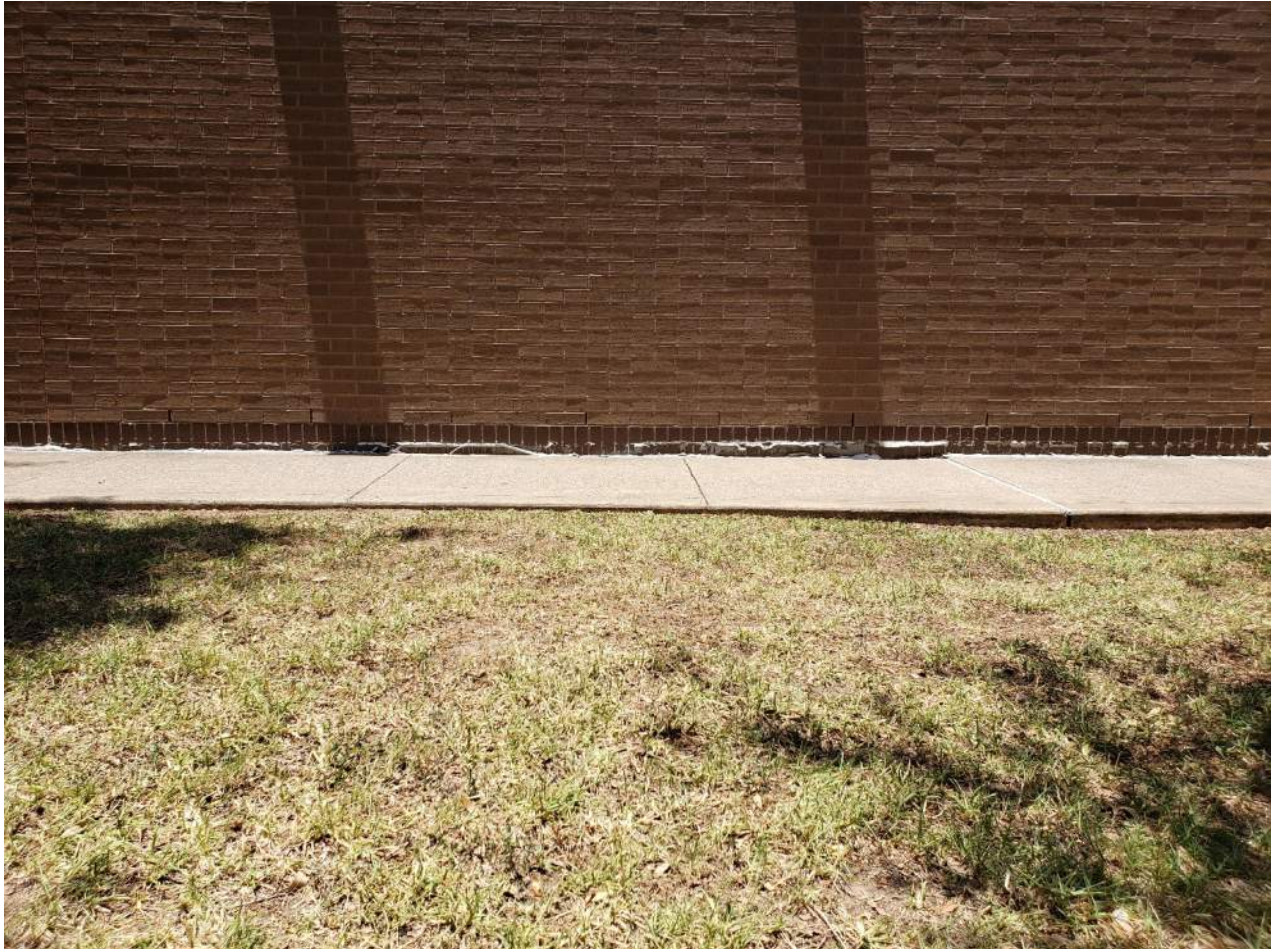
Photo 3

- Vertical movement between the exterior cladding and adjacent paving. (See Photos 3-4.)
  - Cracks in adjacent paving. (See Photo 5.)
  - Cracks in exterior brick cladding. (See Photos 6-7.)

**Description:** Vertical Moment between Exterior Cladding and Adjacent Paving

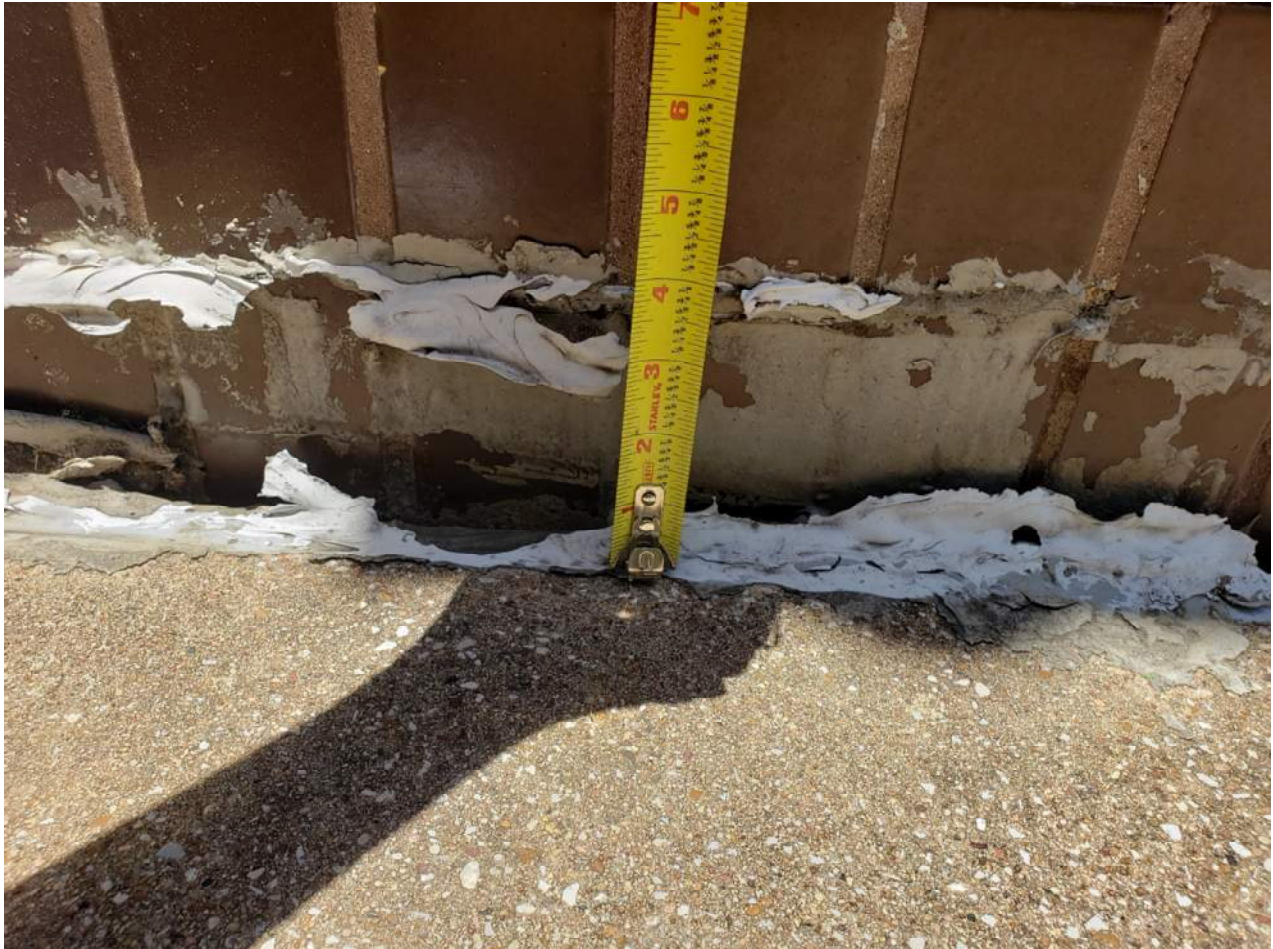
Photo 4

**Description:** 4-Inch Vertical Movement between Exterior Cladding and Adjacent Paving

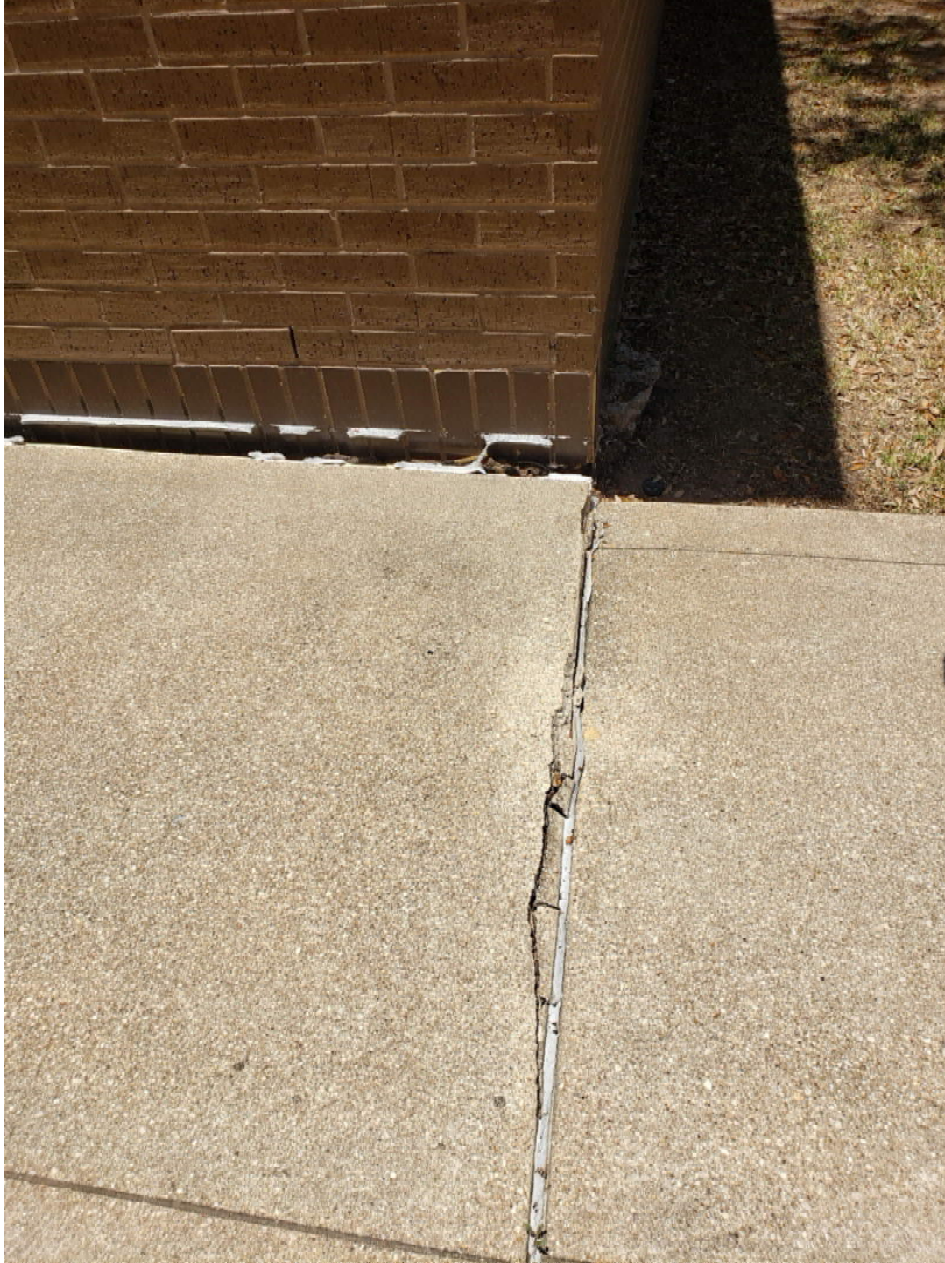
Photo 5

**Description:** Cracks in Adjacent Paving

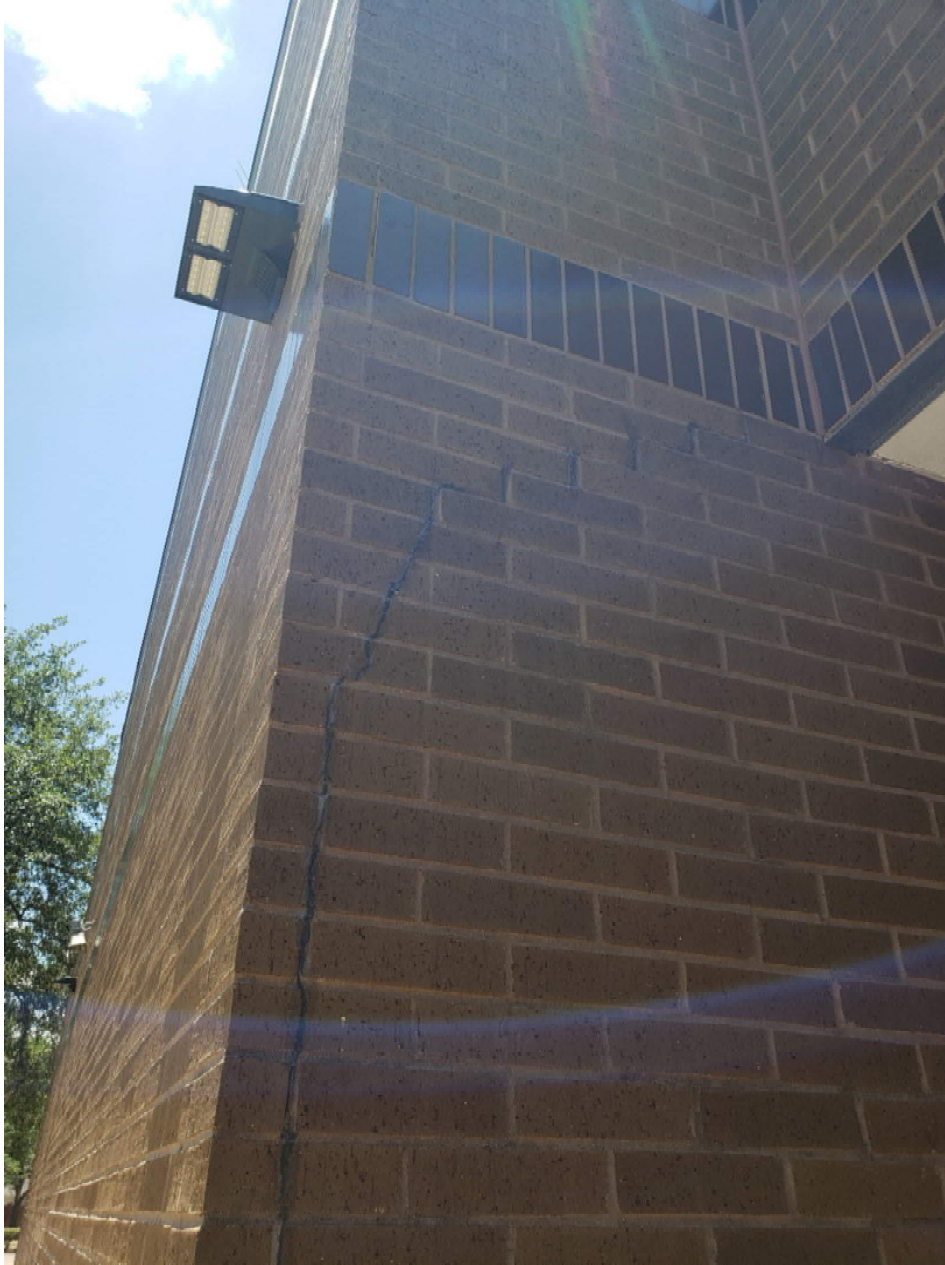
Photo 6

**Description:** Cracks Exterior Brick Cladding

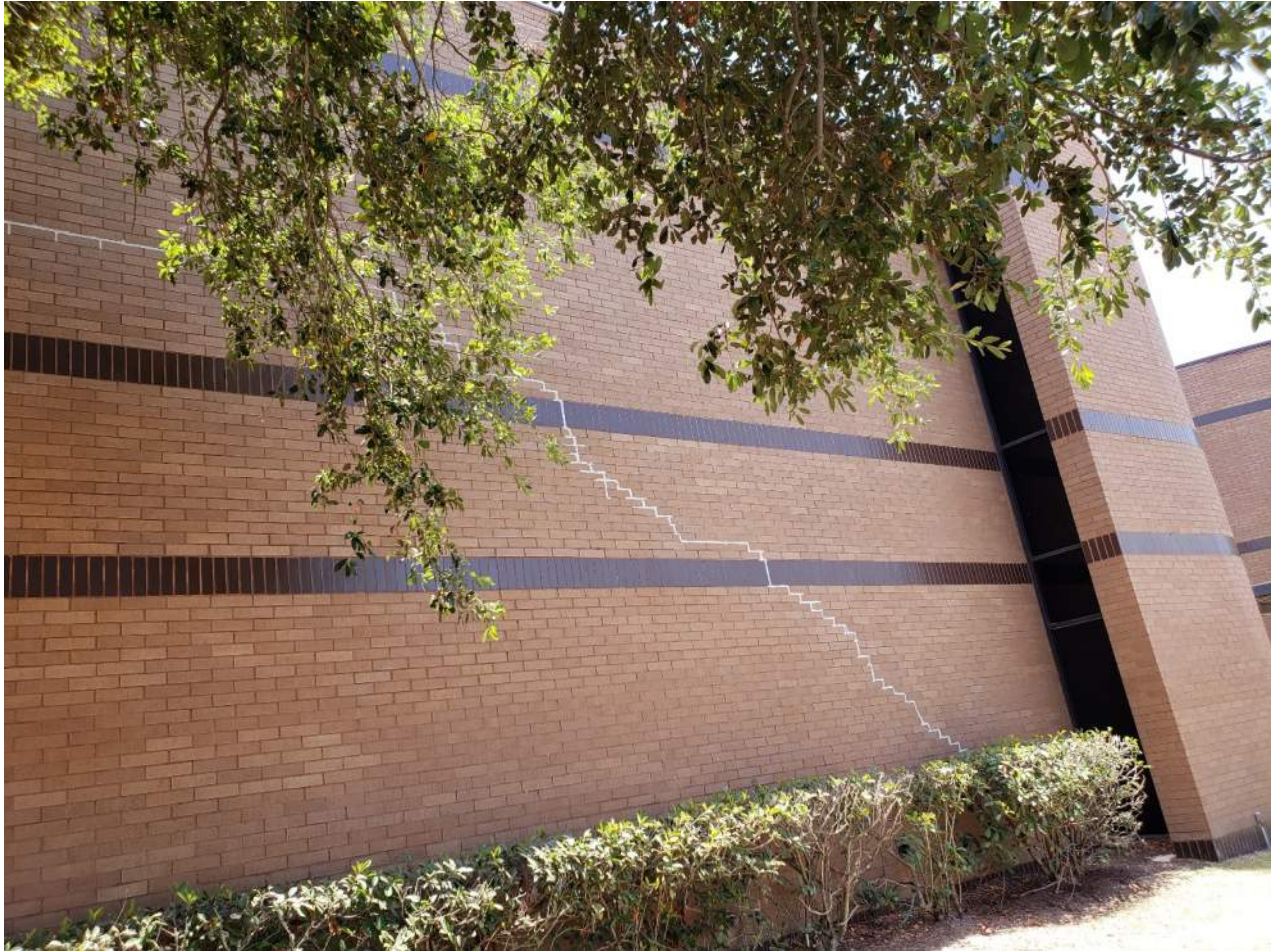
Photo 7

**Description:** Cracks Exterior Brick Cladding

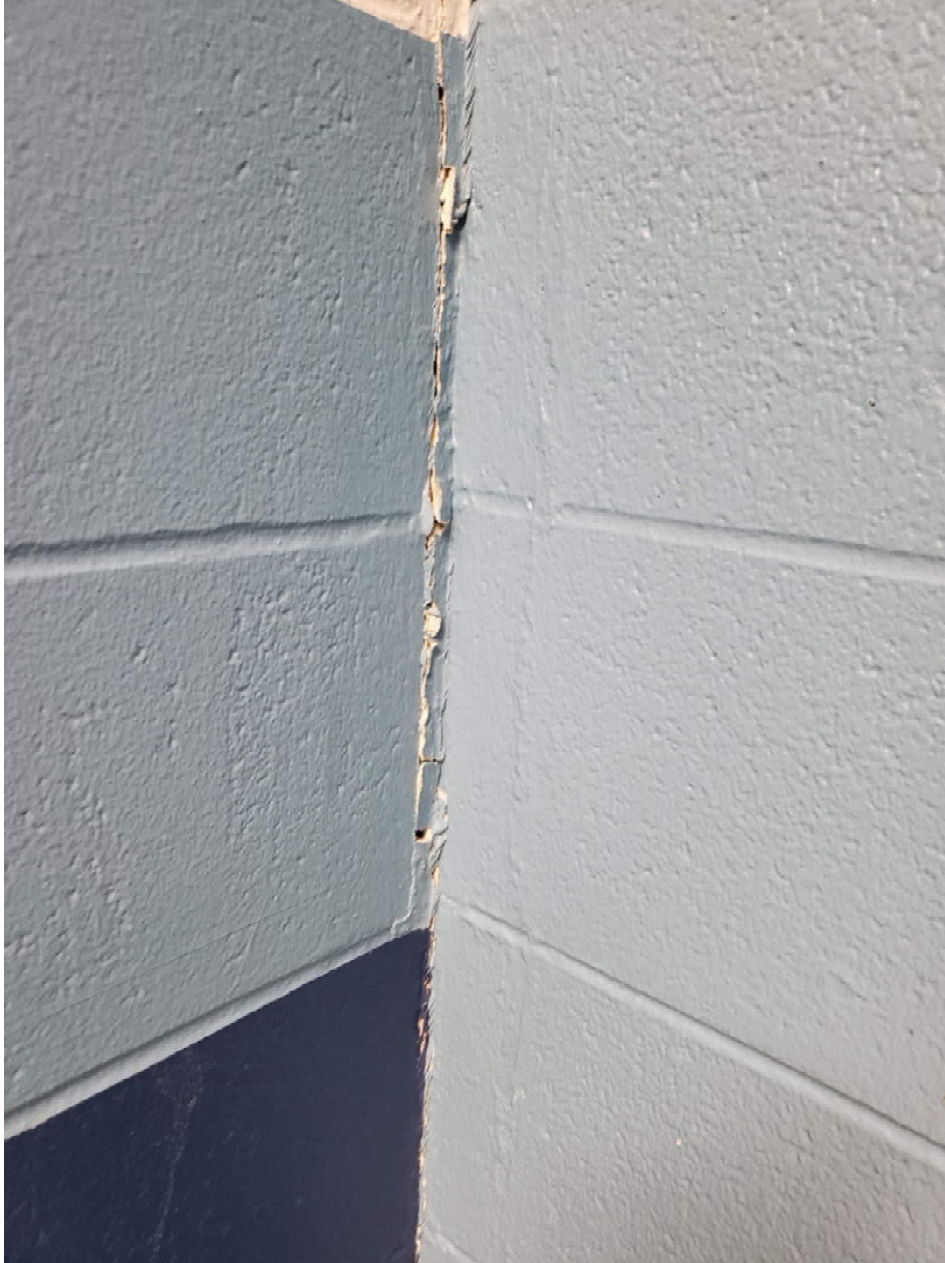
Photo 8

**Description:** Cracks in Non-Load Bearing CMU Walls in Music Hall on Level 1

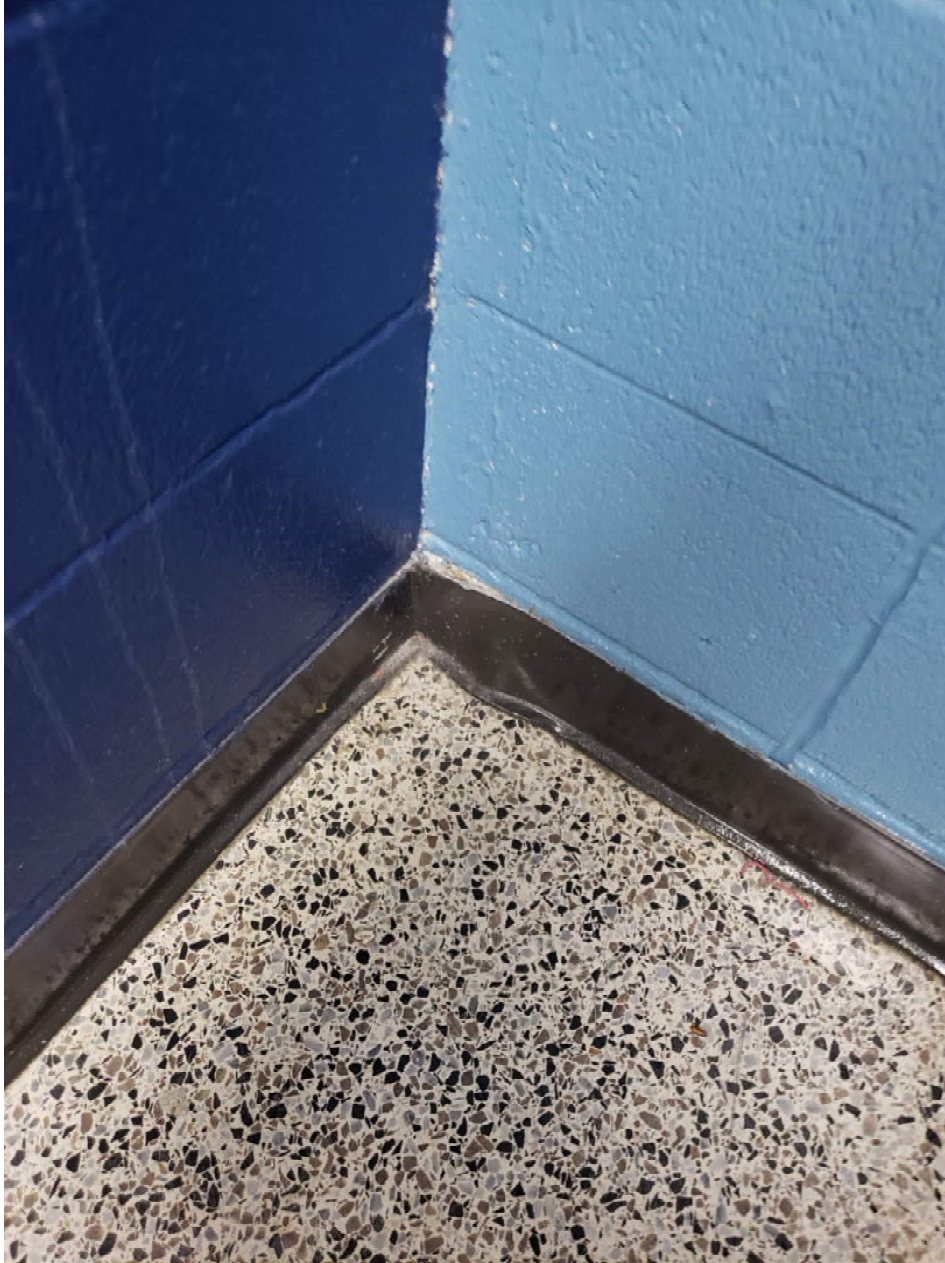
Photo 9

**Description:** Cracks in Non-Load Bearing CMU Walls in Music Hall on Level 1

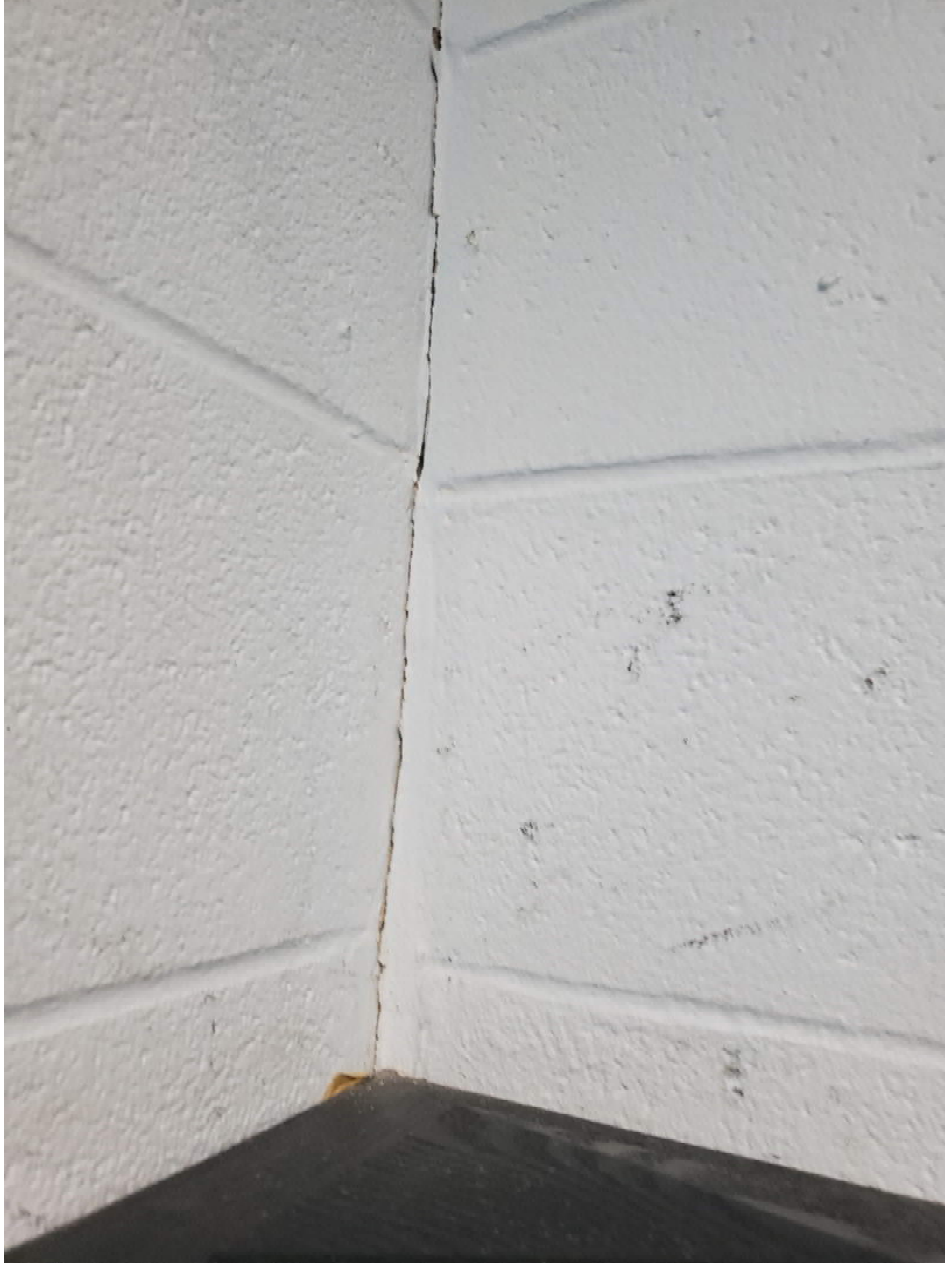
Photo 10

**Description:** Cracks in Non-Load Bearing CMU Walls in Music Hall on Level 1

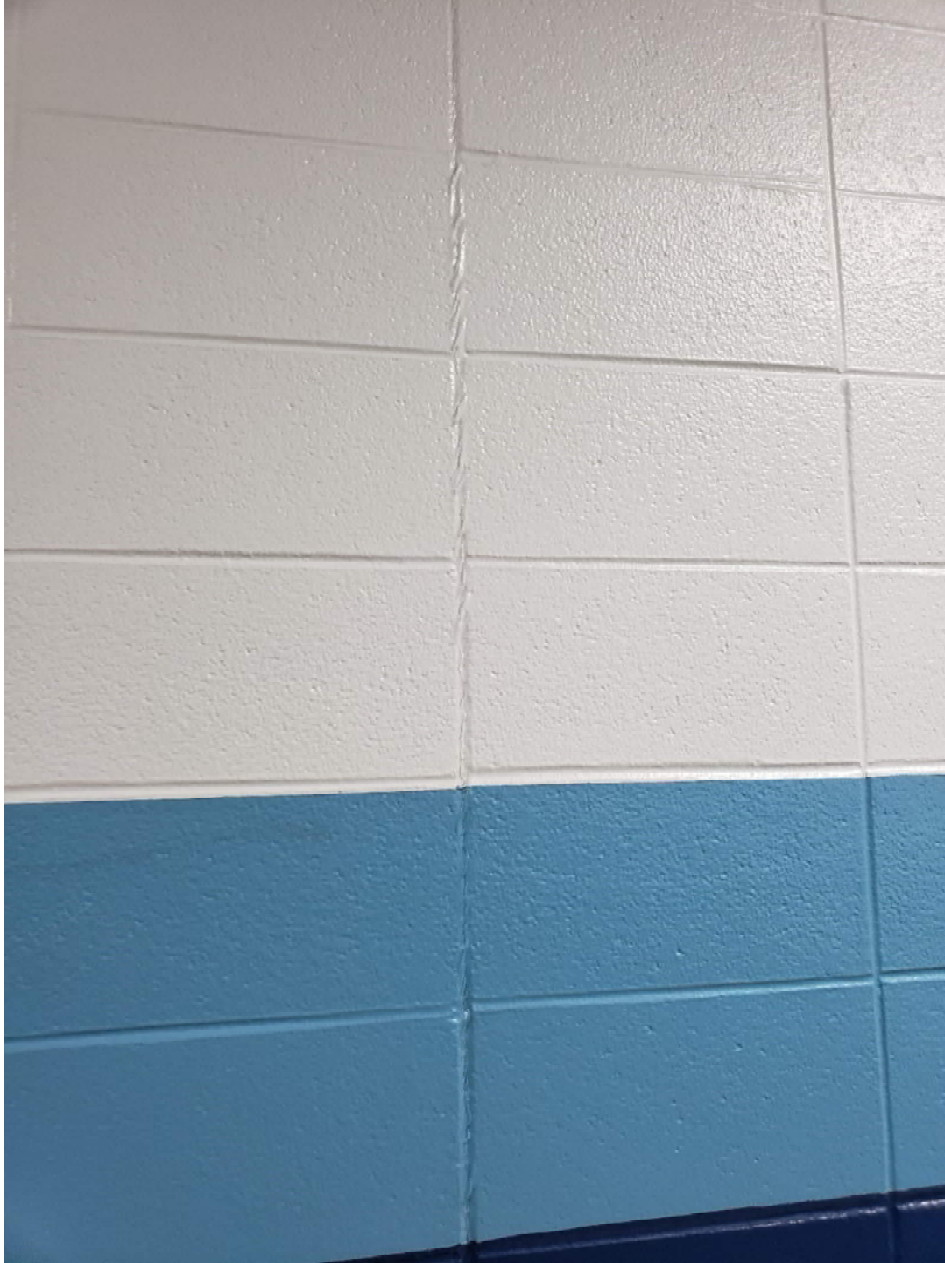
Photo 11

**Description:** Cracks in Non-Load Bearing CMU Walls in Gym Hall on Level 1

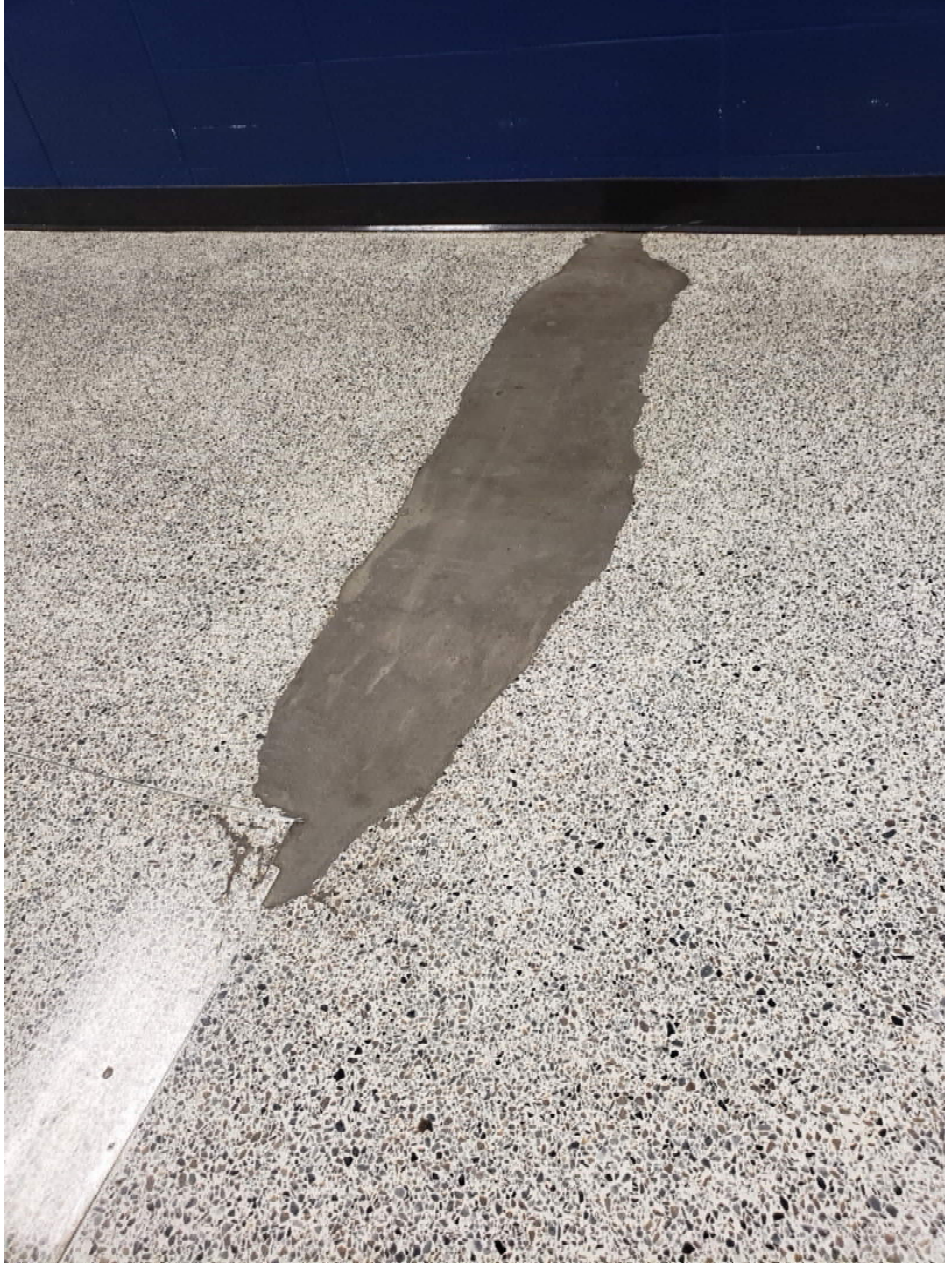
Photo 12

**Description:** Cracks in Flooring of Cafeteria and Hallways on Level 1

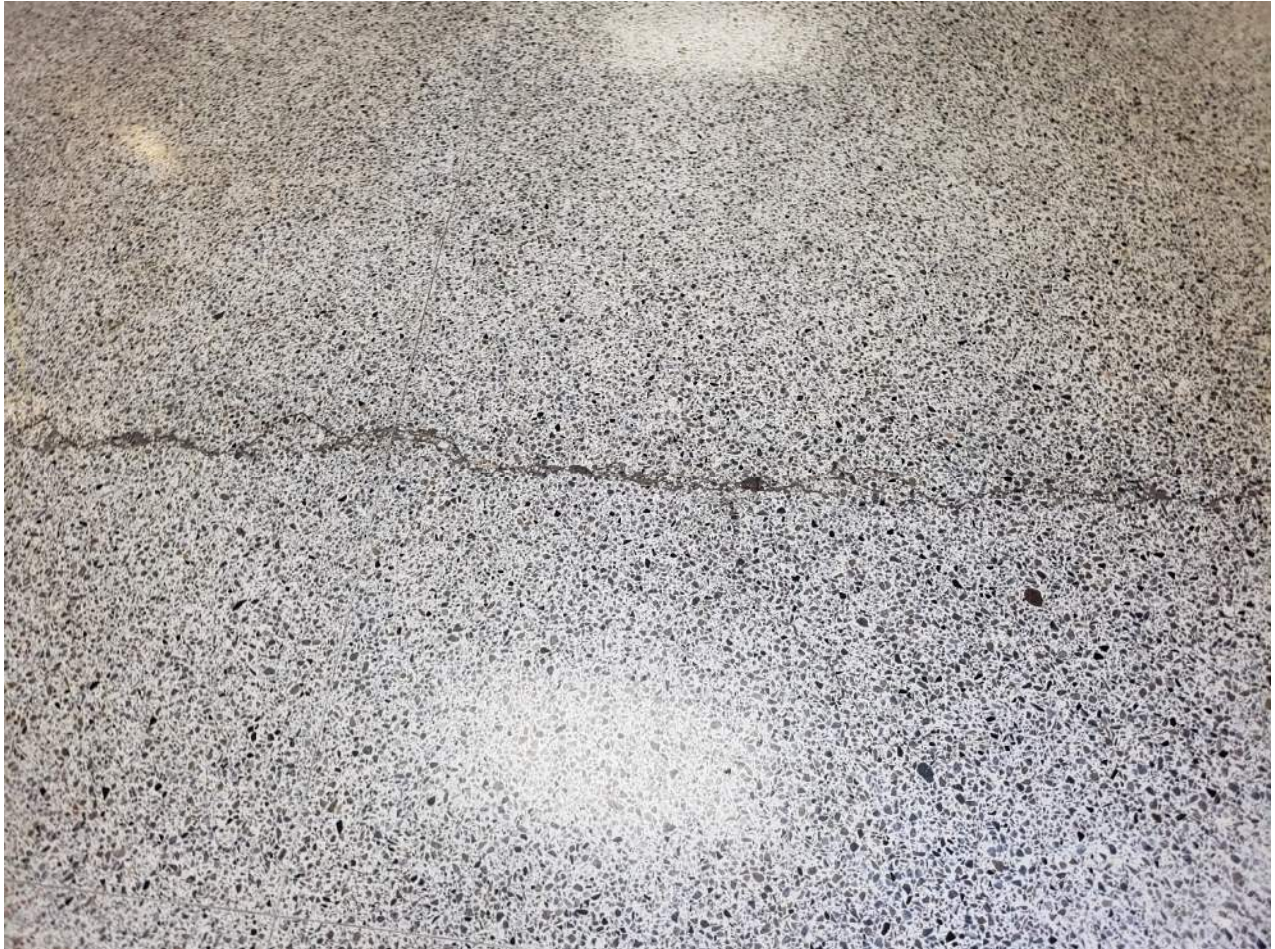
Photo 13

**Description:** Cracks in Flooring of Cafeteria and Hallways on Level 1

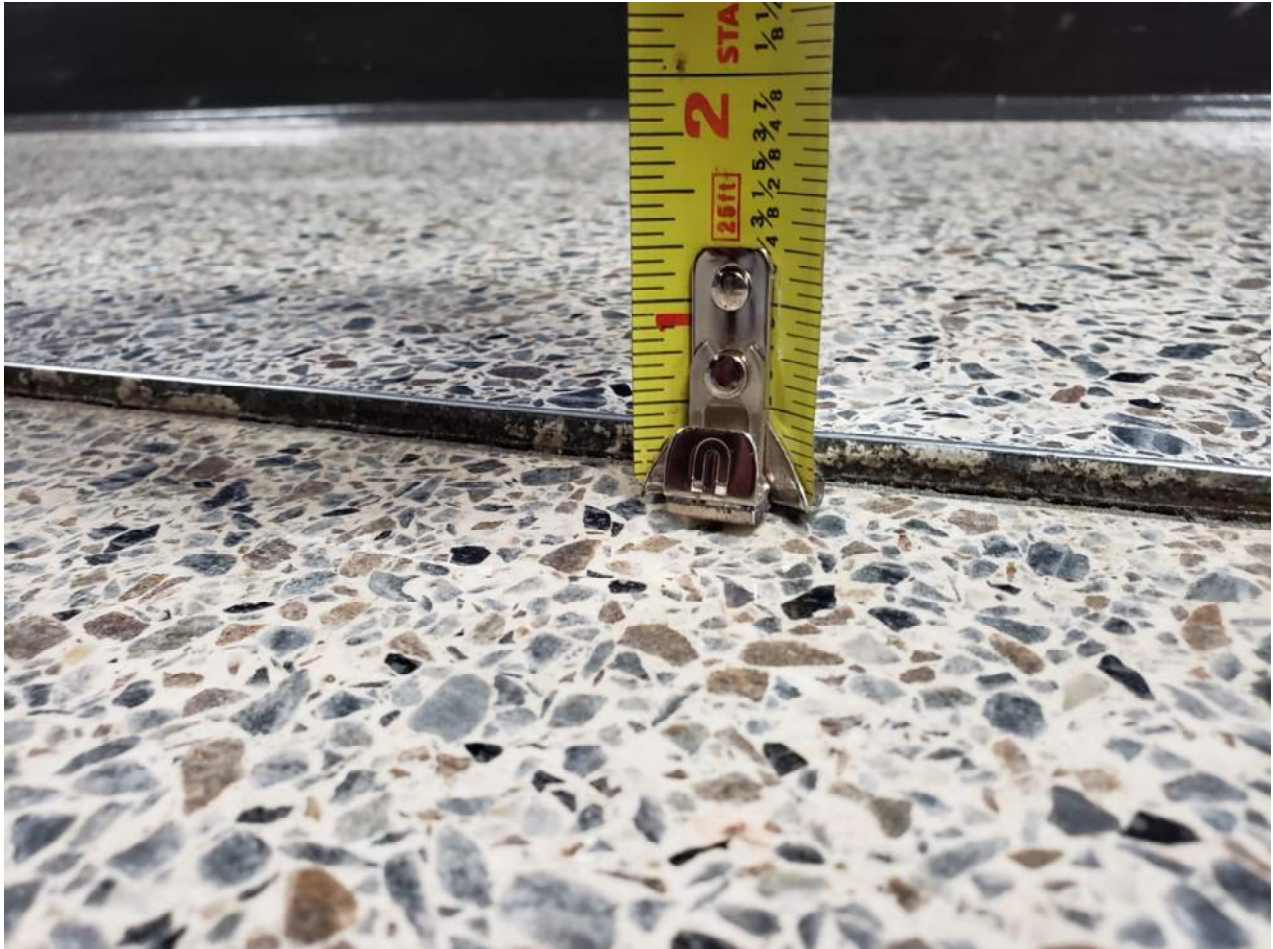
Photo 14

- Cafeteria and hallways. (See Photos 12-13.)
4. Noticeable heaving and settling of subgrade on level 1.
  - Gym hallway. (See Photo 14.)
  - Boys' bathroom. (See Photo 15.)

**Description:** 7/16-Inch Vertical Movement in Flooring of Gym Hallway on Level 1

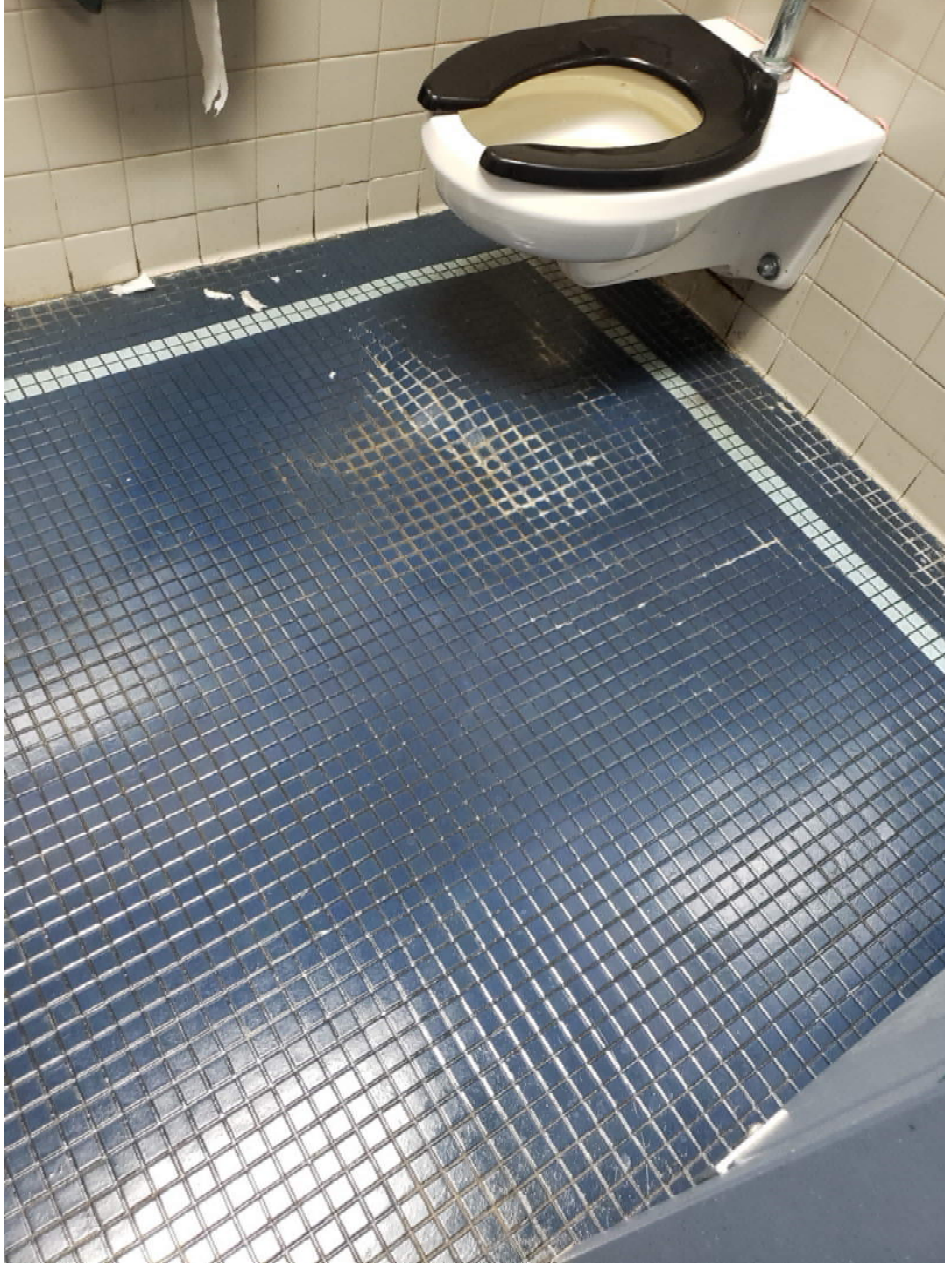
Photo 15

**Description:** Noticeable Heaving and Settling of Subgrade in Boys' Bathroom

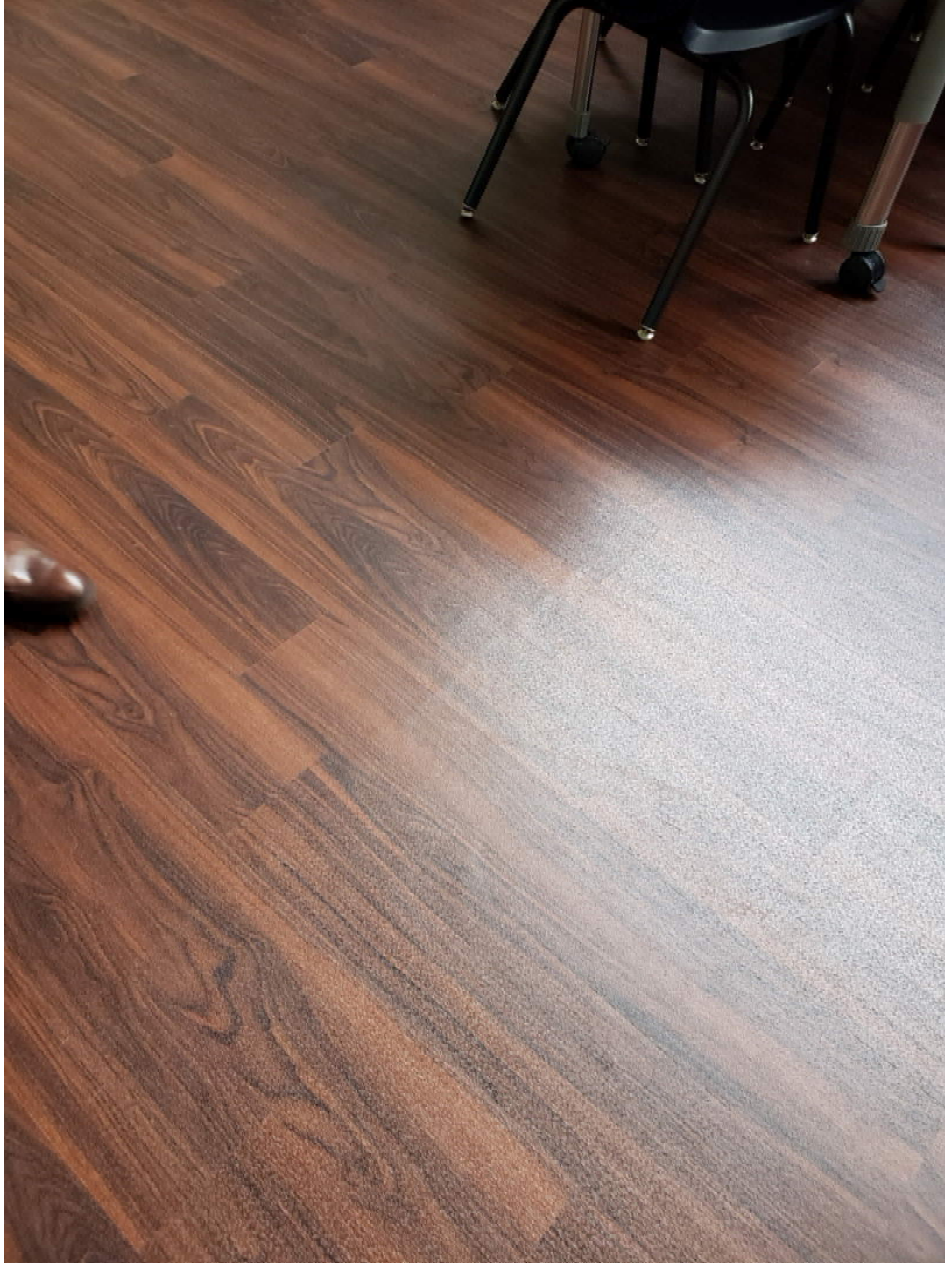
Photo 16

- Library. (See Photo 16.)
5. Significant cracks visible in the flooring at the expansion joint between area A and G, adjacent to the stairs, on level 2.

**Description:** Noticeable Heaving and Settling of Subgrade in Library

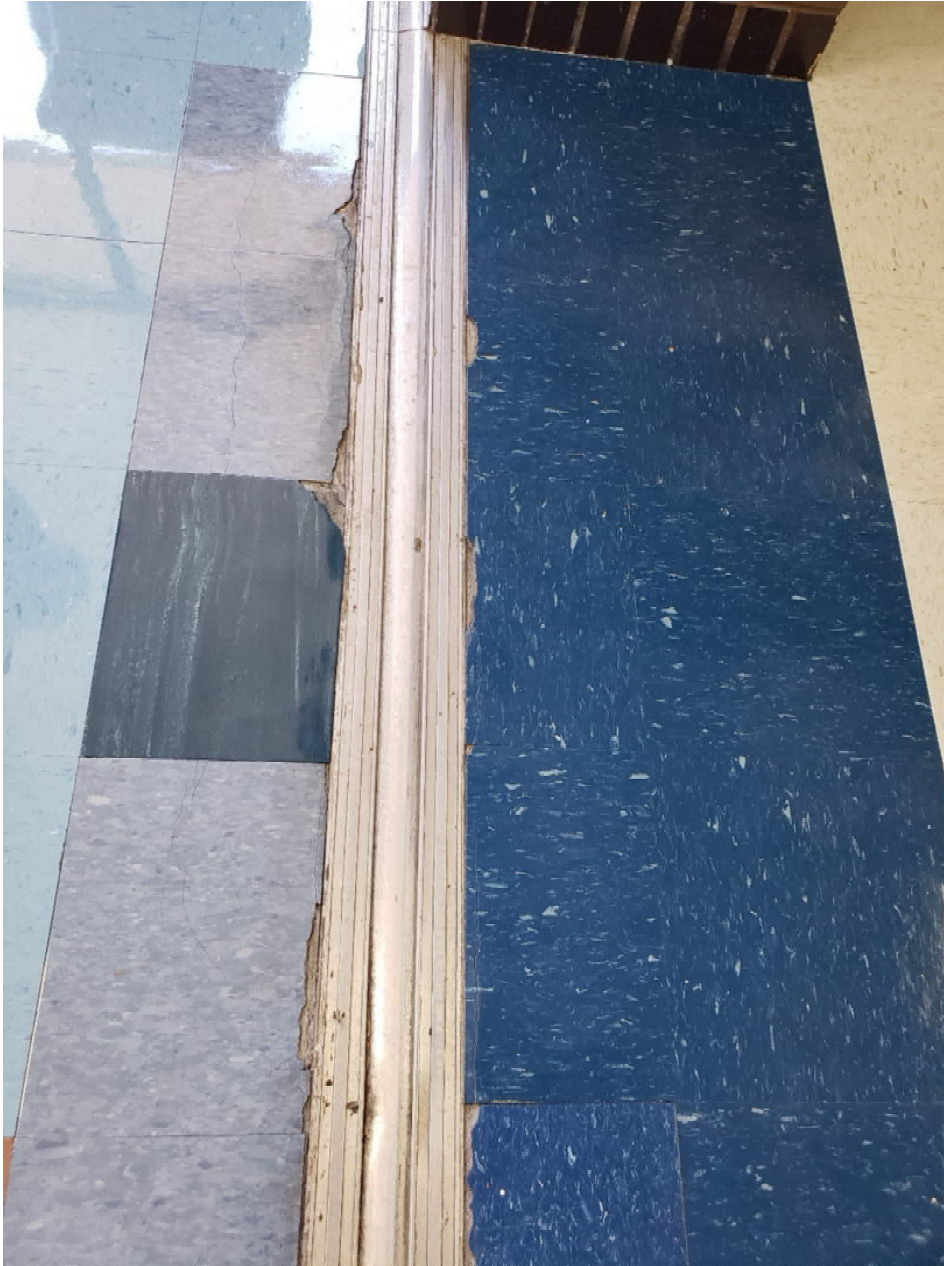
Photo 17

- Cracks in flooring. (See Photo 17.)
  - Structural framing at expansion joint. (See Photo 18.)
  - Structural framing plan (1981 structural drawings) expansion joint. (See Figure 2.)

**Description:** Cracks in Flooring Around Expansion Joint between Area A and G, Adjacent to the Stairs, on Level 2

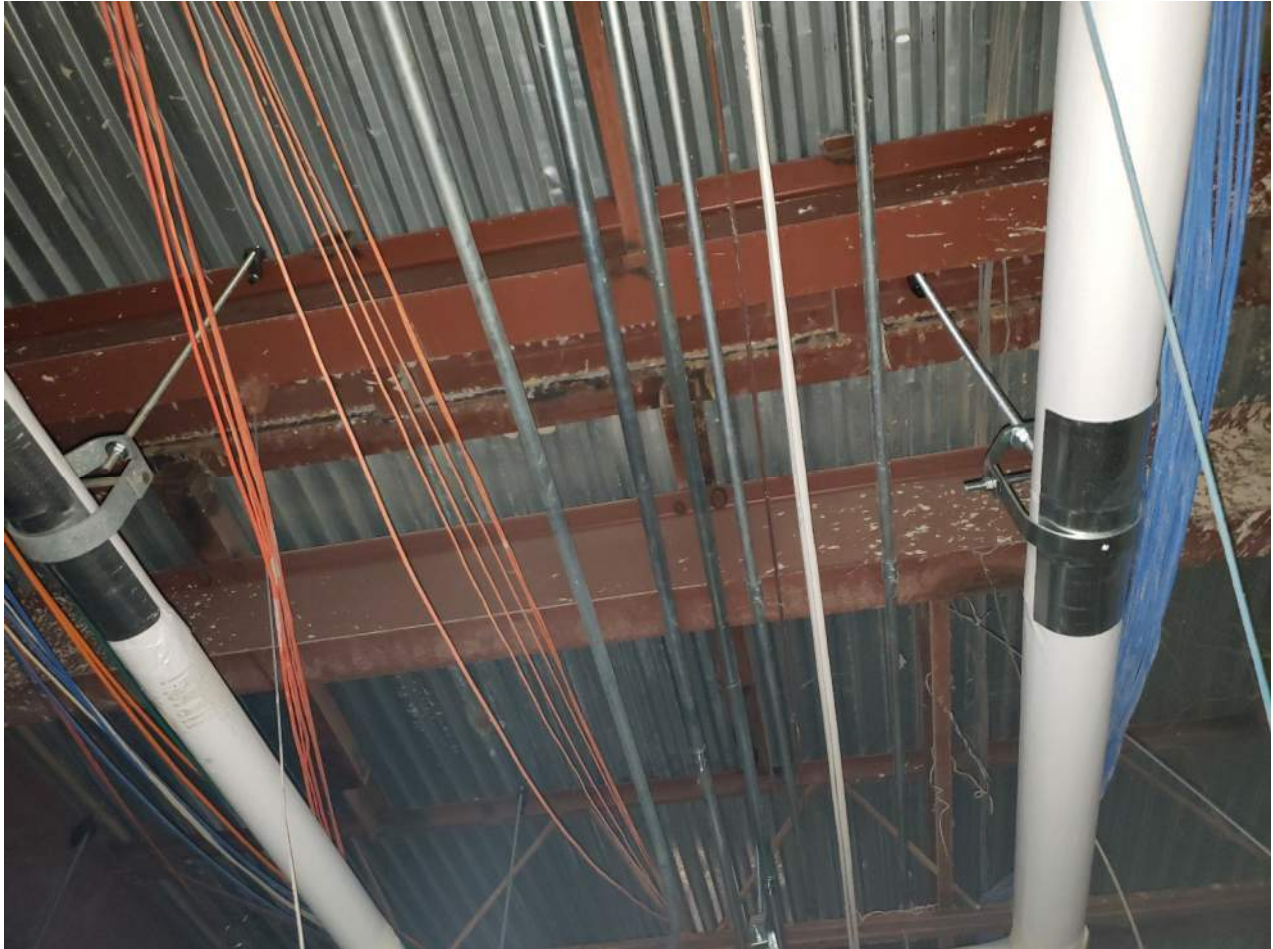
Photo 18

The cracks visible in the flooring at the expansion joint between area A and G, adjacent to the stairs, on level 2 are likely due to the cantilevering outriggers with no back-span (see Photo 18). According to the existing structural drawings, the cantilevering outriggers were designed to have back-spans (see Figures 2-3). Without a back-span for the cantilevering outriggers, the flooring would be subjected to a greater deflection than originally design for.

**Description:** Structural Framing at Expansion Joint between Area A and G, Adjacent to the Stairs, on Level 2
