## STRUCTURAL CONDITION ASSESSMENT REPORT

*Fort Bend Independent School District – Clements High School  
4200 Elkins Road  
Sugar Land, Texas 77479*

**Prepared by:**  
**Dally + Associates, Inc.**  
*9800 Richmond Avenue, St. 460,  
Houston, Texas 77042  
Report No.: 22-219-1  
September 12, 2022*

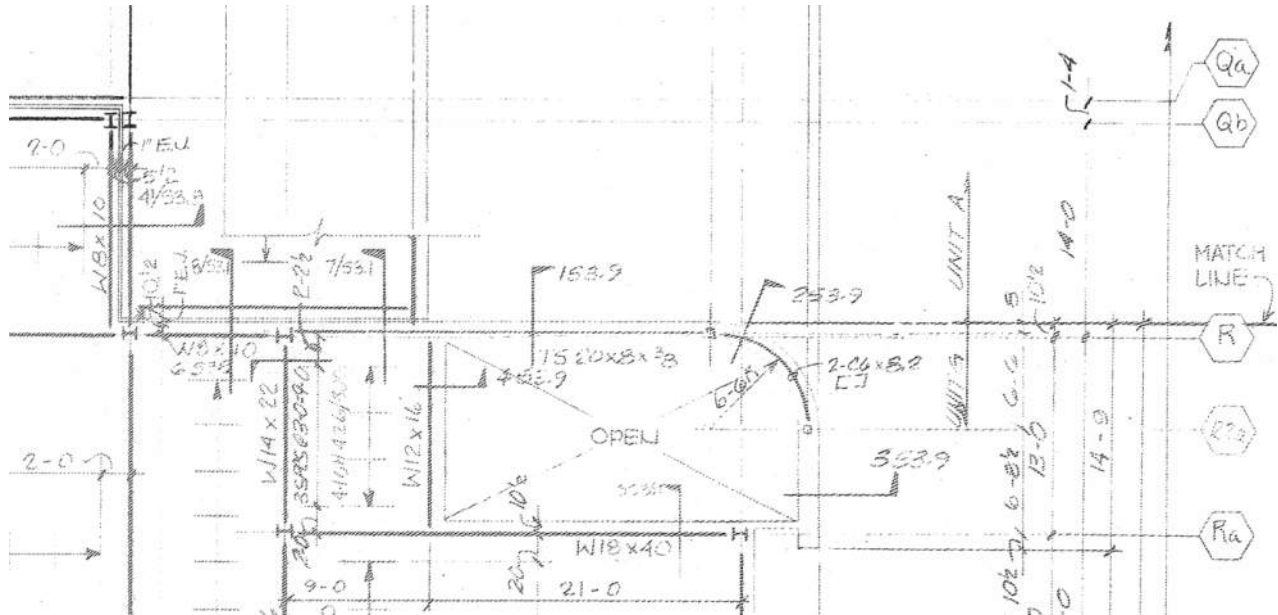
Figure 2

The cracks visible in the flooring at the expansion joint between area A and G, adjacent to the stairs, on level 2 are likely due to the cantilevering outriggers with no back-span (see Photo 18). According to the existing structural drawings, the cantilevering outriggers were designed to have back-spans (see Figures 2-3). Without a back-span for the cantilevering outriggers, the flooring would be subjected to a greater deflection than originally design for.

**Description:** Structural Framing Plan (1981 Structural Drawings) at Expansion Joint between Area A and G, Adjacent to the Stairs, on Level 2

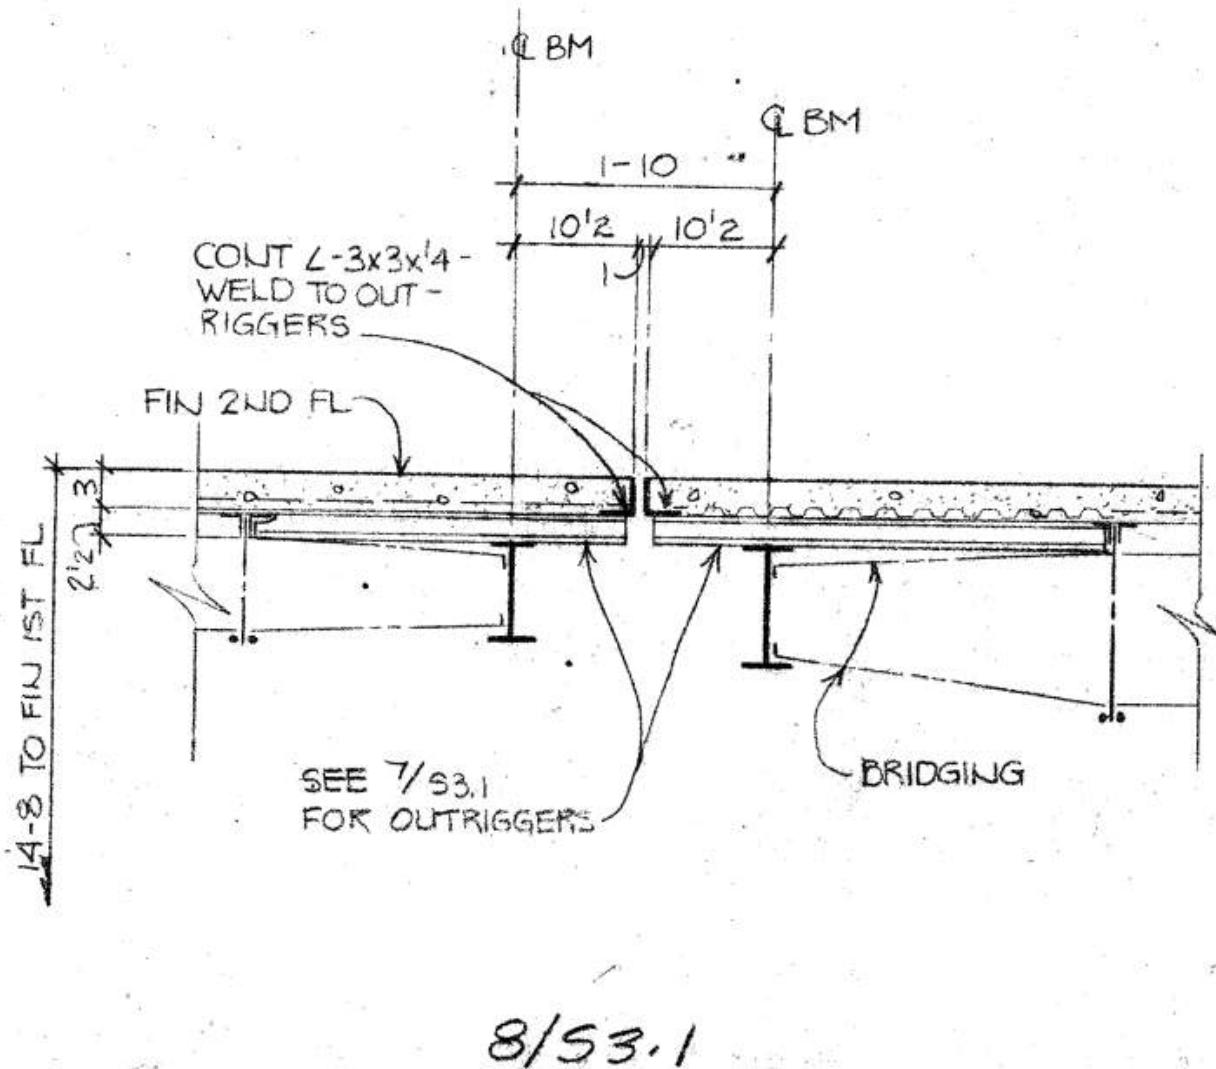
Figure 3

**Description:** Structural Detail (1981 Structural Drawings) at Expansion Joint between Area A and G, Adjacent to the Stairs, on Level 2
