2017

Results of Job Site Safety Audits

*for the Fort Bend Independent School
District*

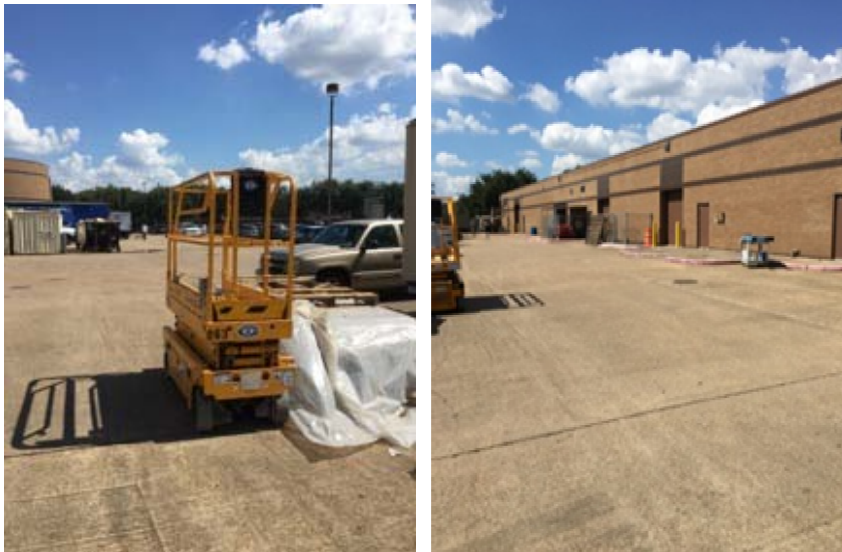
Photographs 1 and 2. Clements High School Job Site

1. The contractor issued badges to those who had passed a background check. All employees present were wearing badges during the site visit.
2. The Principal was notified in advance of construction starting. The contractor had scheduled all “noisy” work around class schedules.
3. There was inadequate separation of the job site trailer, material storage containers, and material staging areas from the students and faculty. Photographs 1 and 2 display the lack of separation from the job site from students and faculty.

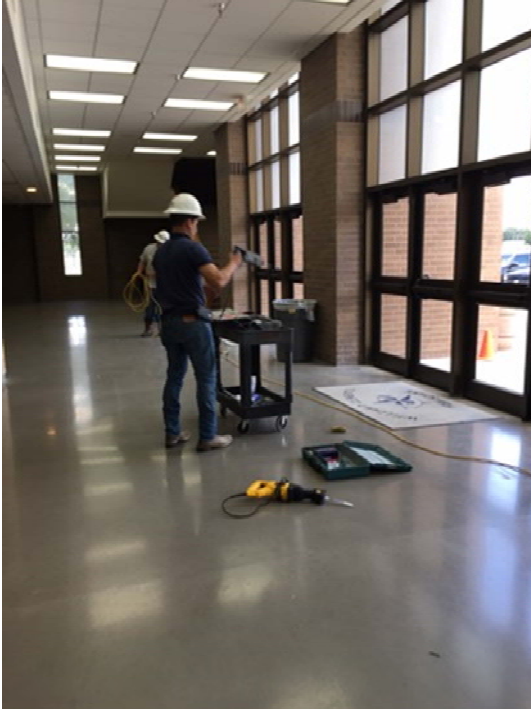
Photograph 3. Clements High School Job Site Work during School Hours

4. Tools and extension cords were in the path of student travel in an around the auditorium entry with students entering and exiting the facility. The Site Superintendent took action to correct this while the inspection team was present, but the practice of working in public areas during active

school hours should be minimized or eliminated in accordance with the SPGM Section 6.1 (a). Photograph 3 displays tools and extension cords in the path of students and faculty.

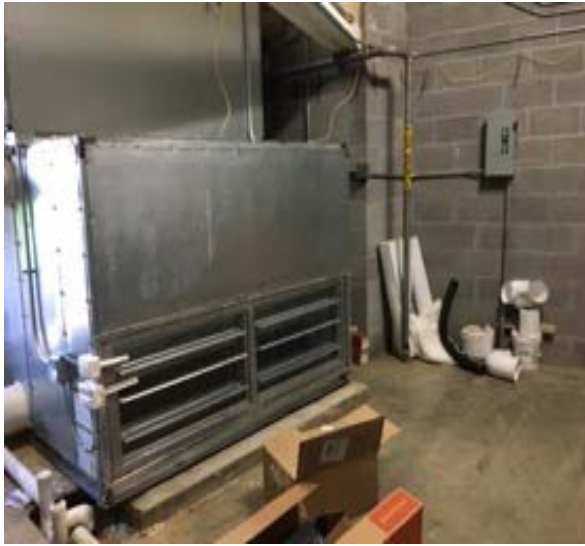
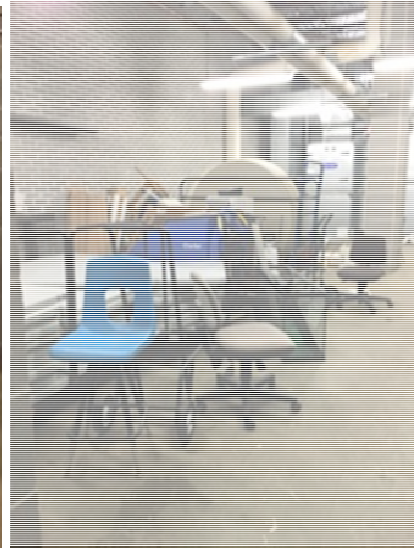
Photographs 4 and 5. Clements High School Mechanical Room

5. Some workers lacked normally accepted Personal Protective Equipment (PPE). Safety vest and protective eye wear were not being used by contraction staff in accordance with safety standards.
6. Public work areas were not protected with cones, barriers, and/or flagmen when necessary.
7. Several mechanical rooms were being used by the contractor and school to store construction materials, such as piping, and by the school to store supplies and desk chairs. Photographs 4 and 5 display construction and school materials stored in mechanical rooms.

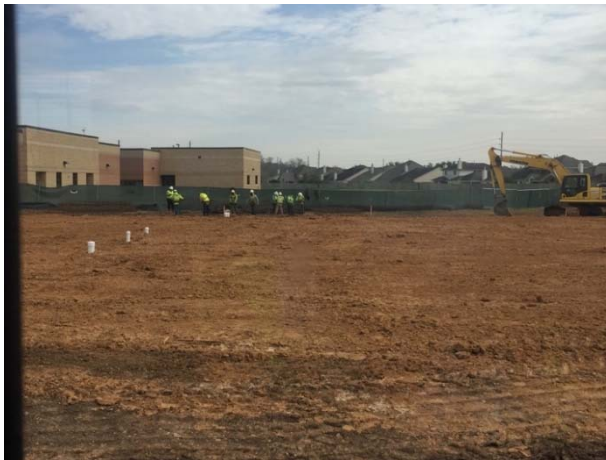
Photograph 6. Schiff Elementary Construction Site Fencing, January 2017

1. The contractor issued badges to those who had passed a background check. All employees present were wearing badges during the site visits.
2. The work area was noted to be reasonably separated from those areas accessed by students and the public. The outside perimeter was fenced off and all connections to the building were secure.
3. The fence gate to the construction entrance was open and no personnel were present. Although Photograph 6 displays the work area properly fenced, Photograph 7 shows the construction gate open, without personnel present.

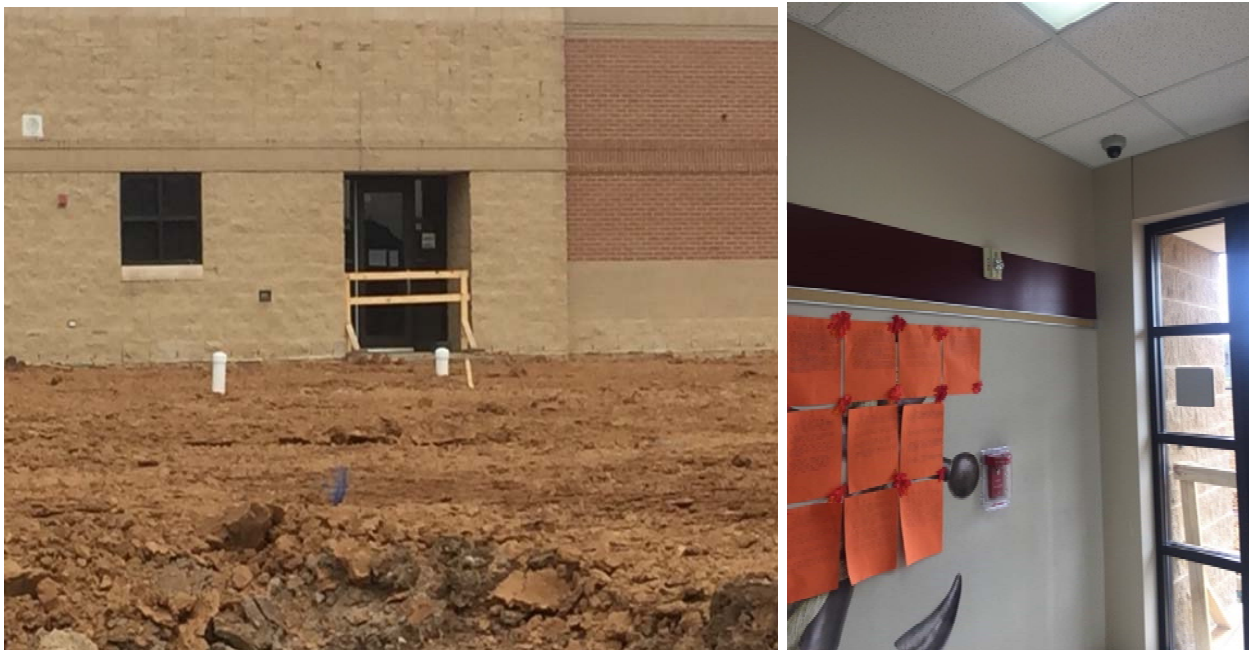
Photographs 8 and 9. Schiff Elementary Emergency Exit, January 2017

4. Public work areas were not protected with cones, barriers, and/or flagmen when necessary.
5. The audit team also viewed an internal emergency exit which was closed for construction. The exit path had been re-routed; however, a “relocation map” was not present. Jacobs SPGM 6.1 (p) states that entrances should not be blocked until staff have been notified and re-routing of students has occurred. There was tape and signage at the door, but there was not a map to show relocation of the fire exit. Photographs 8 and 9 display the outside and inside views of the emergency fire door closed for construction.

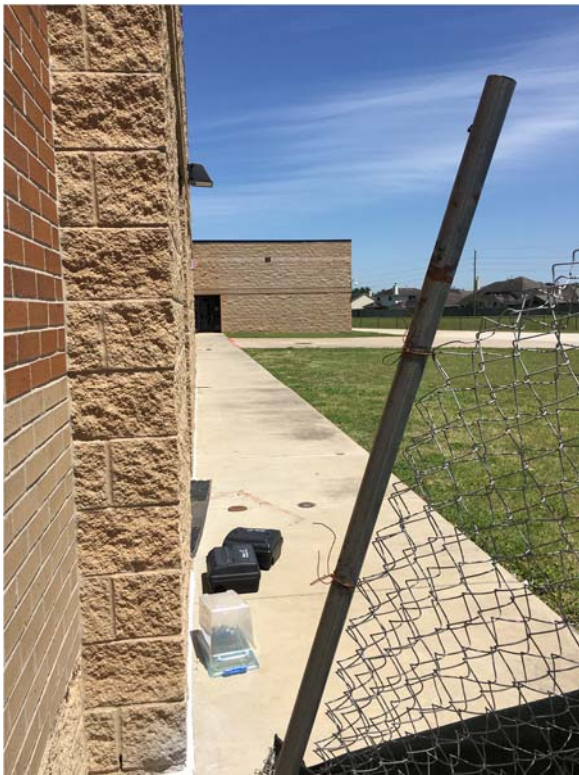
1. There was one instance of the fence being partially open adjacent to the school building (see Photograph 10).

Photograph 10. Schiff Elementary Construction Fence not attached to the school, April 2017

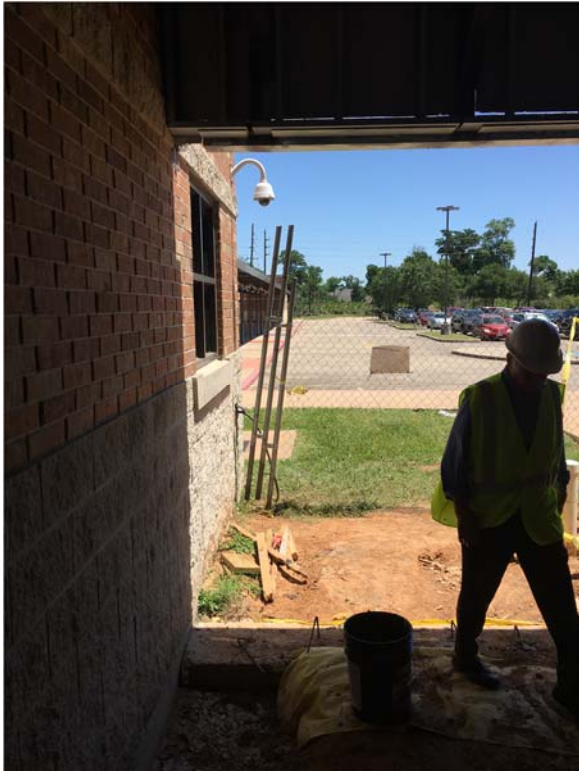
Photograph 11. Scanlan Oaks Elementary Schools, Site Fencing

1. The emergency exits from the school into the construction area were well marked as impassible.
2. There was one instance of the site fence not being attached to the school building itself creating a possible entry for students (see Photograph 11).

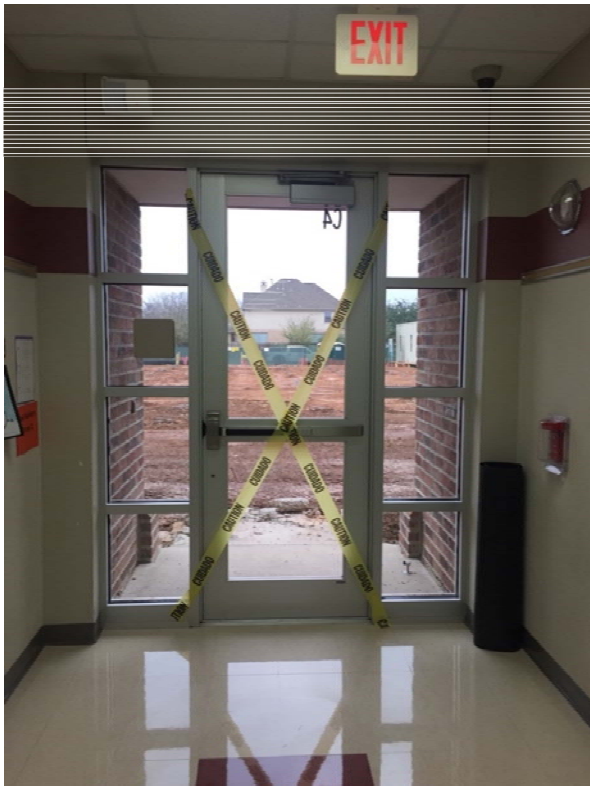
Photograph 12. Cornerstone Elementary School Emergency Exit

1. The principal was notified well in advance of construction starting.
2. The contractor issued badges to those who had passed background checks. All employees present were wearing badges during the site visit.
3. The work area was reasonably separated from those areas accessed by the public. The outside area was fenced off and all connections to the building were secured. All deliveries of materials or heavy machinery were scheduled post student drop off or before student pick up. Internal emergency exits were closed and the exit paths re-routed, but there was no “relocation map” present. Photograph 12 shows the emergency exit blocked off but no relocation map present.

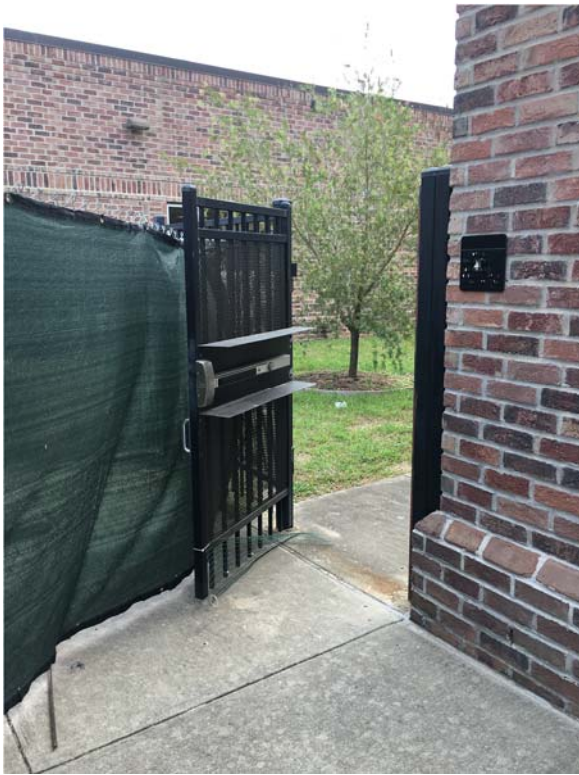
Photograph 13. Cornerstone Open Gate between School Courtyard and Construction Area

The only supplemental finding was an open gate between a school courtyard and the construction area, as shown in Photograph 13.

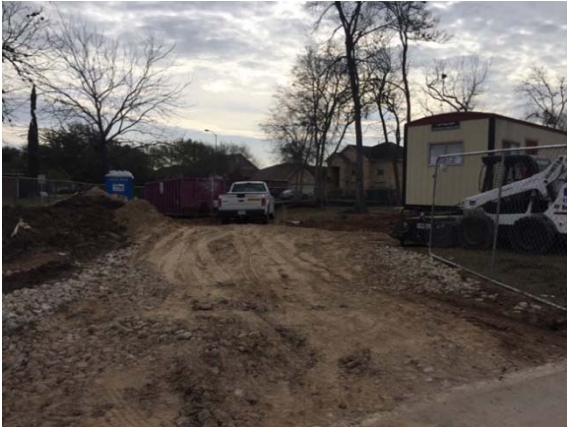
Photograph 13. Oyster Creek Construction Entrance

7. While construction was taking place, the entrance to the construction area was open, with no warning signs posted of possible moving vehicles (see Photograph 13).

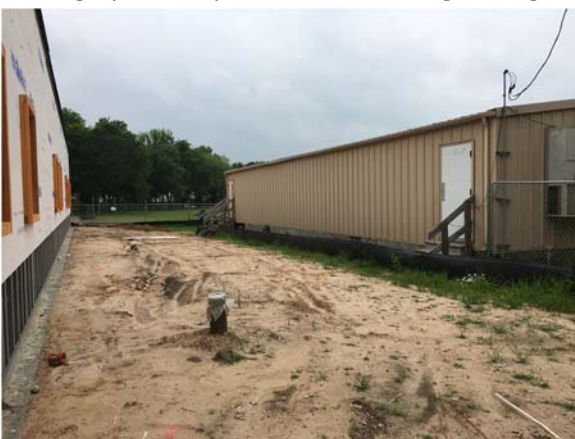
Photograph 14. Oyster Creek Showing Fire Egress from Portable Units

1. There was a fence around the entire work area, and the front gates were closed.
2. Some contractor personnel were wearing badges only when they come inside the school.
3. There was an area of the construction fence that was not attached to itself and could allow students through.
4. There were fire exits from portable classrooms that exited directly into the construction area (see Photograph 14).

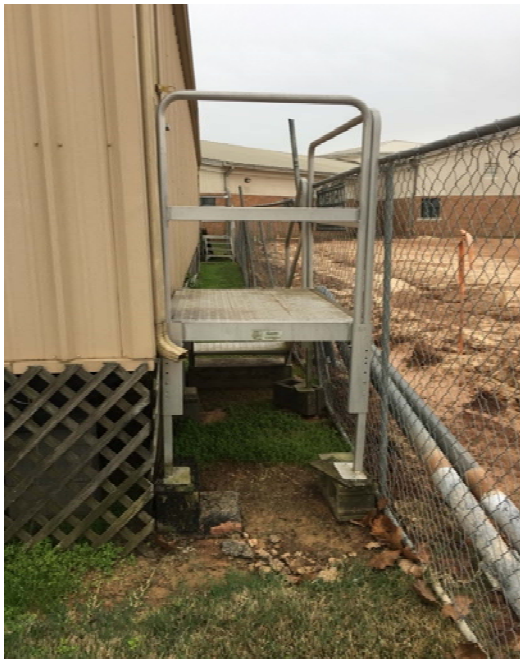
Photograph 15. Sienna Crossing Portable Classroom

1. Because the contractor was not working at the time of the site visit, the audit team could not assess whether the staff of the contractor were wearing badges or had passed background checks.
2. There are no regular project meetings that include the principal, the contractor, the architect, and the program manager.
3. There was a location where the emergency exits and stairs pointed inward from the portable classrooms and were not providing sufficient space for many students to escape. Photograph 15 shows portable classroom exits providing insufficient space to escape between the unit and the construction fence.

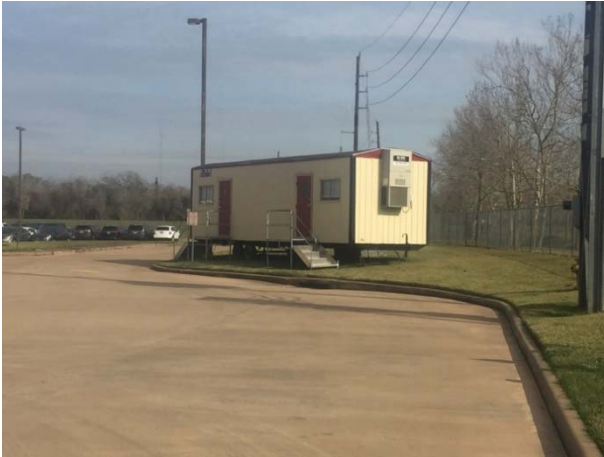
Photograph 16. Sienna Crossing Construction Trailer

4. Internal emergency exits were closed and the exit paths re-routed, but a “relocation map” was not present.
5. The work area fencing was not consistently secured either to the building or to itself. Photograph 16 shows the trailer outside the fenced in area. Photographs 17 and 18 provide examples of how a fence was not consistently secured around the construction site in multiple areas.

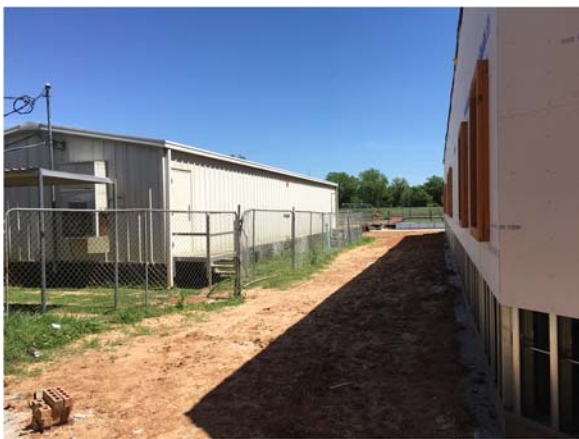
Photograph 19. Sienna Crossing Fence away from Portables Fire Exit

- All aspects of the project that involve the existing building, including the tie-ins and the replacement of air handling units will wait until the school building is empty in June.
- The audit team noted that the construction contractor had corrected all of the previously identified problems. Photograph 19 below displays how construction fence was moved away from the portables. Photograph 20 displays the site plans in the front lobby.

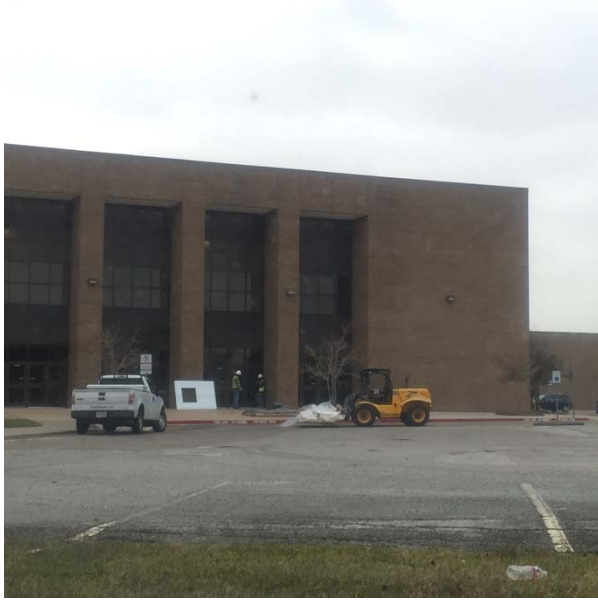
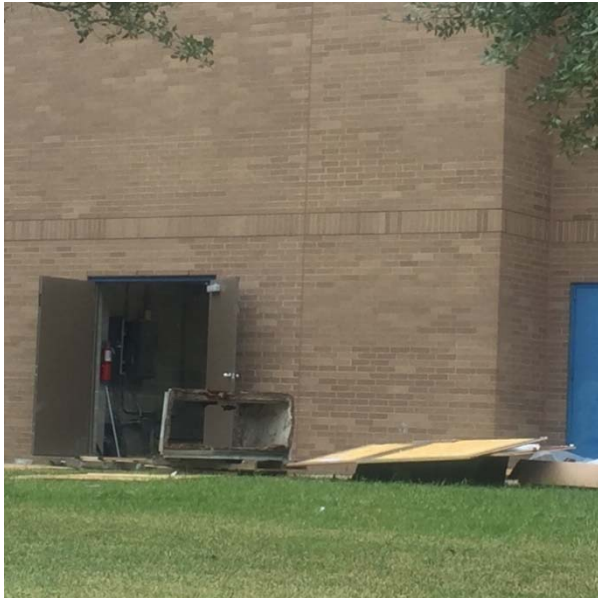
5. Proper warning signage was not present around the trailer, storage areas, or work underway.
6. No proper fencing around one construction site, although no students were present. Photographs 21 and 22 show the lack of fencing around this construction area.

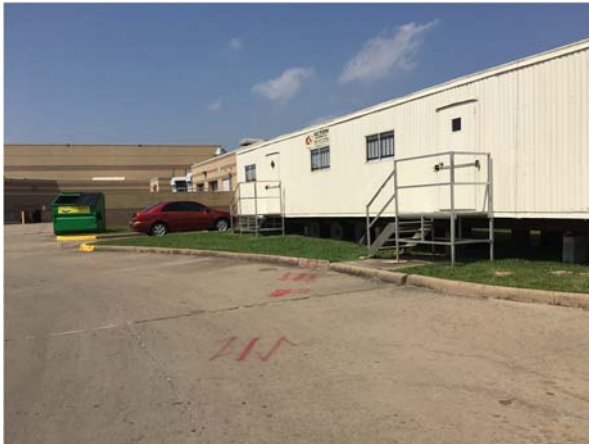
Photograph 23. Austin High Showing the Construction Trailer

1. The principal reported that personnel working for the contractor have badges. Workers were not present when the audit team was on site.
2. The construction trailer was located outside the fenced-off construction area (see Photograph 23).
