2017

Results of Job Site Safety Audits

*for the Fort Bend Independent School
District*

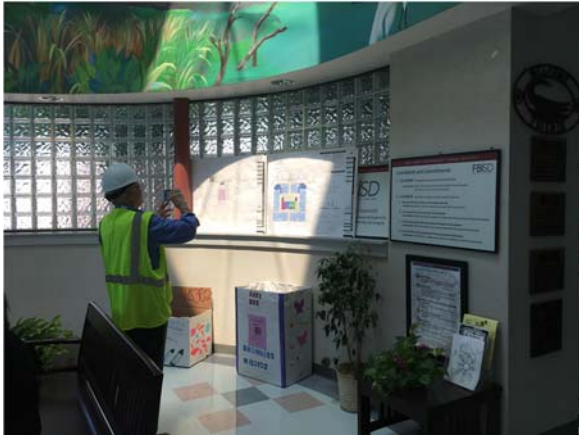
Photograph 20. Sienna Crossing Showing Lobby and Plan of Classroom Addition

- All aspects of the project that involve the existing building, including the tie-ins and the replacement of air handling units will wait until the school building is empty in June.
- The audit team noted that the construction contractor had corrected all of the previously identified problems. Photograph 19 below displays how construction fence was moved away from the portables. Photograph 20 displays the site plans in the front lobby.
